Hilina Pali 2002  
HAVO-2005-D-33  
Feature 98-838, wall  
April 2005  
Cartography By J. Burrell

Hilina Pali 2002  
 HAVO-2005-D-35  
 Feature 98-840, enclosure  
 April 2005  
 Cartography By J. Burrell

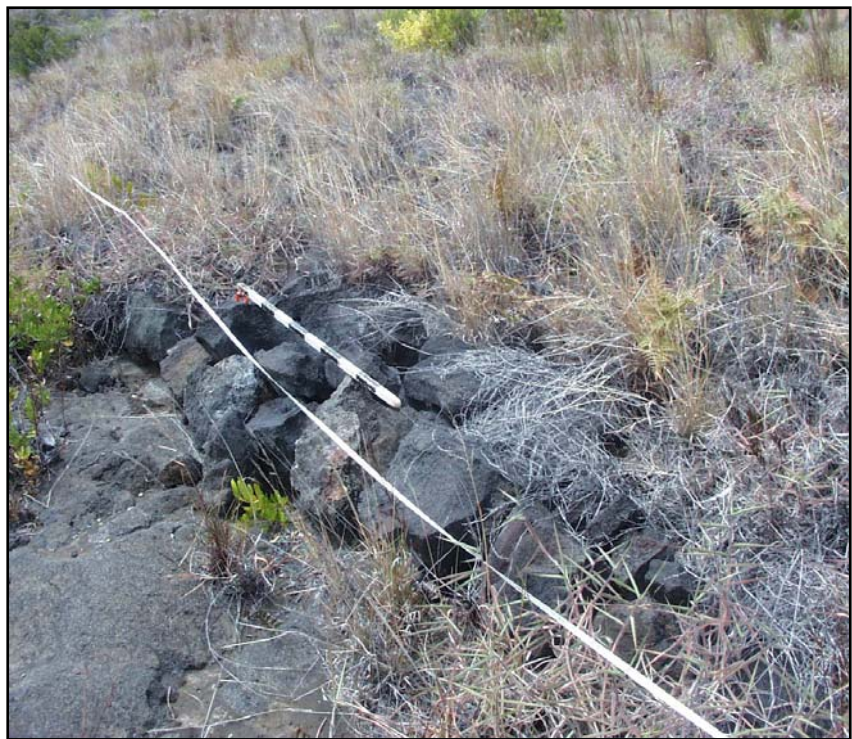
**Figure 56. HAVO-2005-D-95, Rock Wall.**

**HAVO-2005-D-95** (Feature 02-44) is a 12 m x 70 cm x 42 cm high wall. It is constructed of blocky pāhoehoe rocks stacked to a height of 1 to 2 rocks high. It is located southeast of 02-41. The rocks are cobble and boulder sized. The middle section of the wall is the best preserved. Types of impact include vegetation, seismic, weathering, and water. Vegetation consists of

*pūkiawe*, *a'ali'i*, partridge pea, fern, and grasses. This feature is in fair to poor condition.

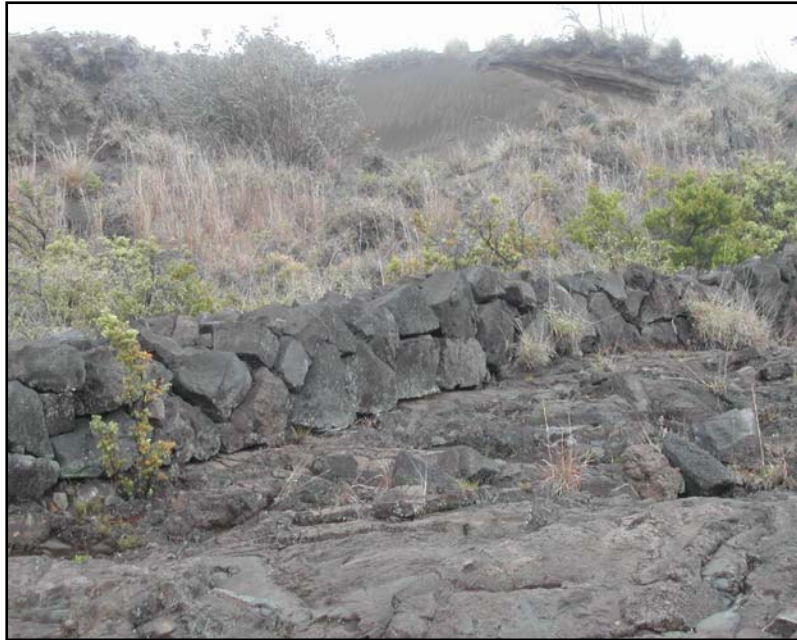
**Figure 59. Feature HAVO-2005-D-107, rock wall**

**HAVO-2005-D-107** (Feature 03-06) is an 8.5m X 50-110 cm wide X 40-60 cm in height rock wall. This is a very long rock wall built on the western edge of a pāhoehoe outcrop. The wall trends northwest-southeast. The southern portion of the wall is built with very blocky pāhoehoe boulders that are dry stacked very neatly so that they fit together nicely. The construction is very impressive. This portion of the wall is very linear approximately 30m long. After 30 m the wall is constructed with pāhoehoe boulders and also a lot of pahoehoe cobbles. The wall is not as intact and looks slightly collapsed and is invaded by vegetation. This wall is dry stacked 3-4 courses high. The function of the wall is as a retainer for water. To the west of the wall there are sand dunes. To the east of the wall is a pāhoehoe outcrop where the water is encouraged to flow into the drainage over the pahoehoe lava flow. Seismic activity, erosion and vegetation are potentially impacting this feature.

Vegetation surrounding this feature includes *pūkiawe*, *‘ōhi‘a*, ferns, grasses and *a‘ali‘i*. This feature is in excellent condition

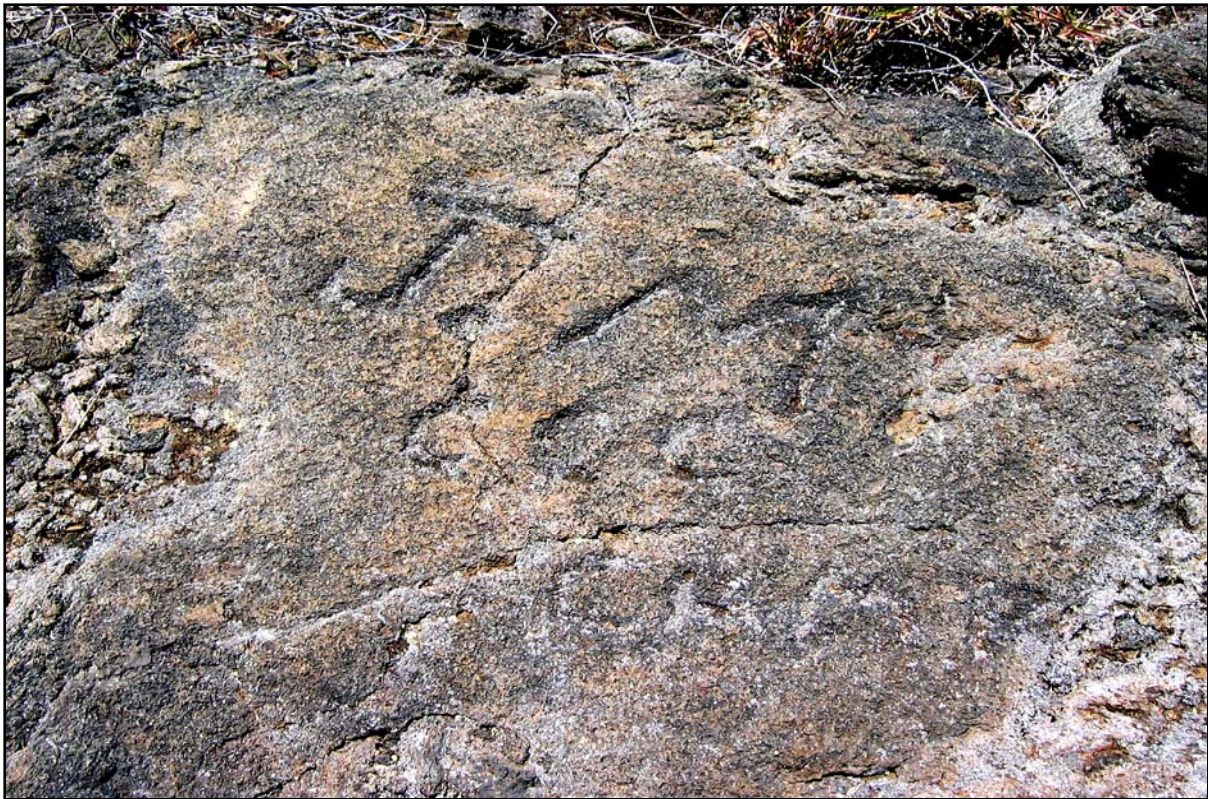
**Figure 61. Site Number 50-10-62-24523, HAVO-2005-D-110, Petroglyph**  
Photo Courtesy of the National Park Service

**HAVO-2005-D-110** (Feature 03-12) is a 45 cm X 30 cm pecked petroglyph. The petroglyph is pecked from pāhoehoe bedrock and is comprised of the letters "J. M." and underneath these letters are the letters "C.C.C. Camp". Also within a 5 meter vicinity of this petroglyph are three others. One reads the initials "E C H," one is not legible and the other one reads H M L with the letters connected. The petroglyph is large and visible and located near a rock shelter overhang opening (03-14) as well as another C.C.C petroglyph recorded in (03-17). The area the feature is located in is vegetated by *pūkiawe*, *‘ōhi‘a*, *a‘ali‘i* and grasses. It is in excellent condition (see figure 61).

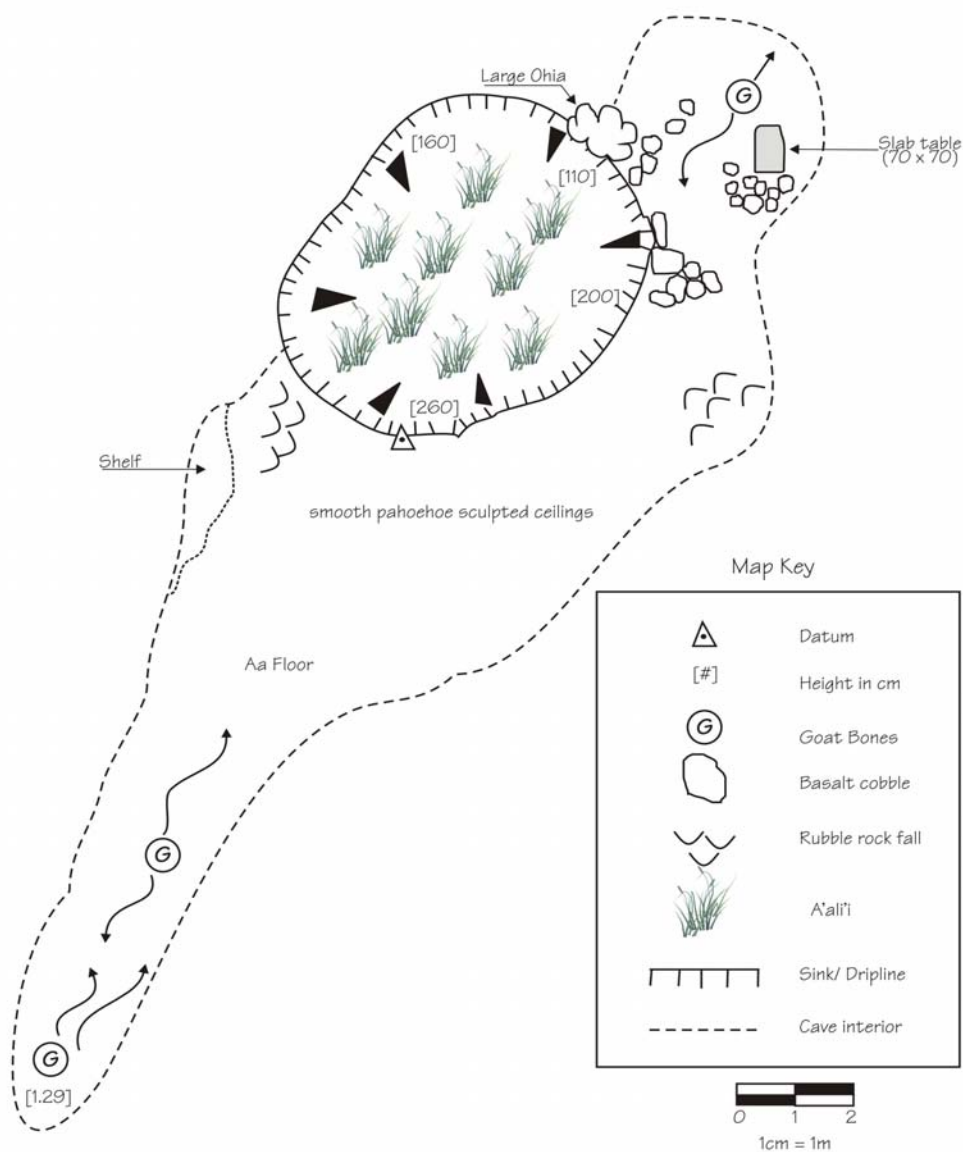
Figure 62. Site Number 50-10-62-24524, Feature HAVO-2005-D-116, Rock Shelter

**HAVO-2005-D-116** (Feature 03-14) is a overhang/rock shelter formed in the natural pāhoehoe flow. The dimensions of the entrance sink are 7 m X 5 m X 1-3 m deep. The opening of the tube is very circular and is being invaded by vegetation. On the east side of the tube opening is a

small room with the dimensions 6 m X 2.8 m X 1.25 m high. In this room there is a deliberately made table constructed from a large pāhoehoe slab (approximately 1m X 1.5 m) that rests on top of five stacked pāhoehoe blocks. The table is approximately 0.5 m high from the tube floor. The tubular portion of the cave extends towards the south and is full of goat bones. It goes back approximately 15 meters and possibly continues but the continuation is not accessible from this portion of the tube. The southern portion of the rock shelter has very impressive geological formations at the entrance on the smooth pahoehoe walls. The formations are smooth and includes a pillar and a complex web of lava flow formations. This section of the rock shelter extends back approximately 14 meters. This tube would serve as a good shelter and found near two CCC petroglyphs. The vegetation of the area includes *a'ali'i*, *'ōhi'a*, *pūkiawe*, and grasses. The impacts of the feature include goats, vegetation, and human impacts and the feature is in good condition.

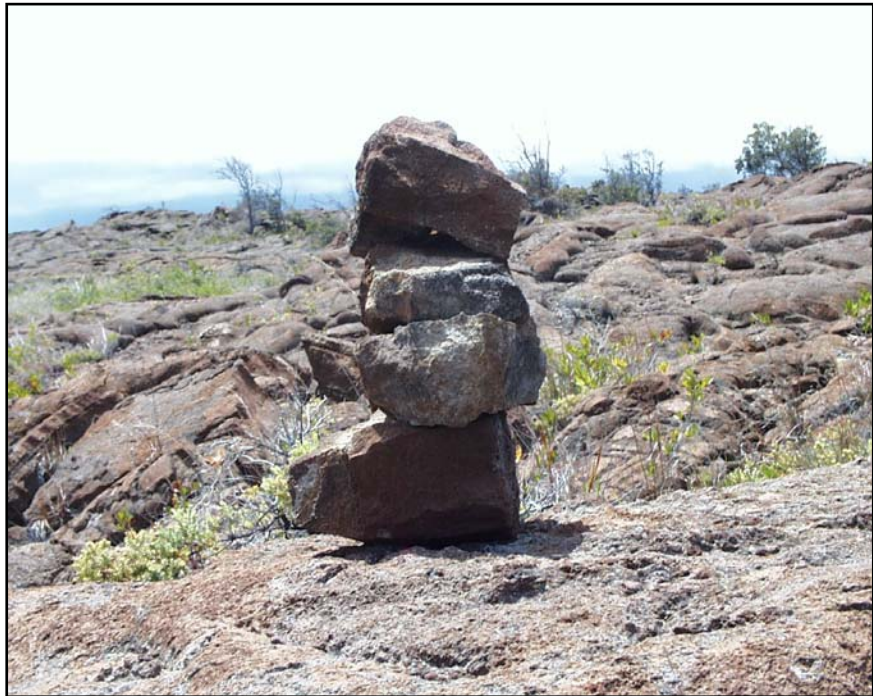
**Figure 75. HAVO-2005-D-151. Ahu trail marker**

(Feature 03-11) is a 0.45 m long X 0.20 m wide X 0.65 m in height *ahu* located approximately 40 meters away from the trail and *ahu* at feature 98-387. The *ahu* is constructed with small to large pāhoehoe cobbles stacked 4 courses high. This feature could potentially be impacted by seismic activity.

Vegetation surrounding this feature includes *‘ōhi‘a*, *pūkiawe* and *a‘ali‘i*. This feature is in excellent condition
