Tech Notes

WINDOWS

Installing Insulating Glass in Existing Steel Windows

MERGENTHALER LINOTYPE BUILDING

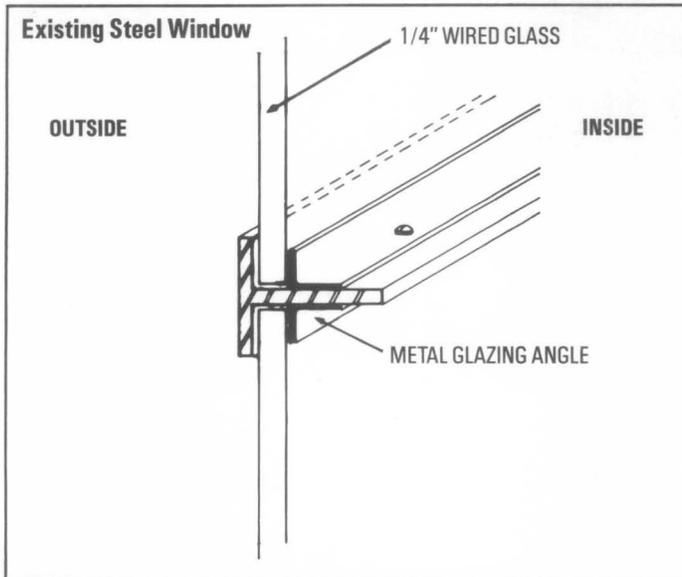
Figure 2. Spring glazing clips and face putty were used instead of the original metal glazing angles in installing the new glass. Drawings: Martha L. Werenfels

The original wire glass had been held in place by glazing angles bolted to the muntin bars. In removing the glass it was decided, due to deterioration of the glazing angles and the labor-intensiveness of reinstallation, that new spring glazing clips and steel sash glazing compound would be used instead (*see figure 2*).

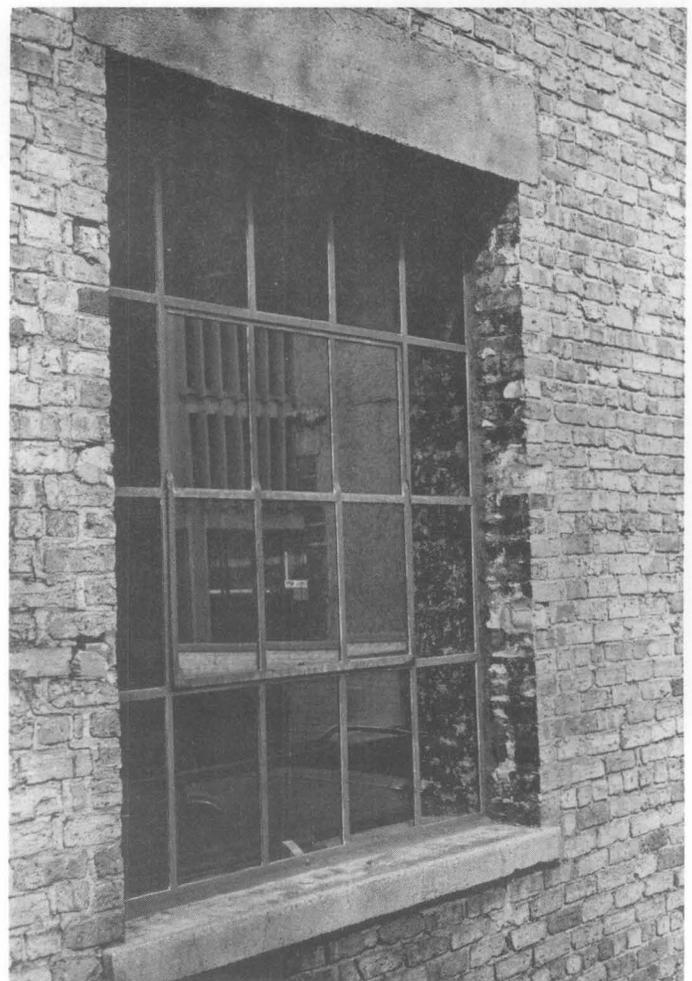
Figure 3. The historic steel windows were repaired and then upgraded through the addition of insulating glass. Photo: Charles E. Fisher

After the metal glazing angles and glass were removed, the old frames were scraped off and existing paint layers and rust were removed using sand under air pressure. After cleaning, sections from several old windows that had been removed were welded into the remaining windows to replace missing

or deteriorated metal pieces. At the same time, racked metal sections, especially the center-pivoting hopper units, were realigned by applying heat and pressure. All the metal was then painted with an anti-corrosive paint.
