## Drakes Estero Restoration Project Eelgrass Monitoring Report: Year 3<sup>1</sup>

Ben Becker<sup>2</sup>, Sarah Codde, Amelia Ryan<sup>3</sup>, Taylor Ellis, and Brannon Ketcham  
Point Reyes National Seashore  
Point Reyes Station, CA 94956

### 1. Summary

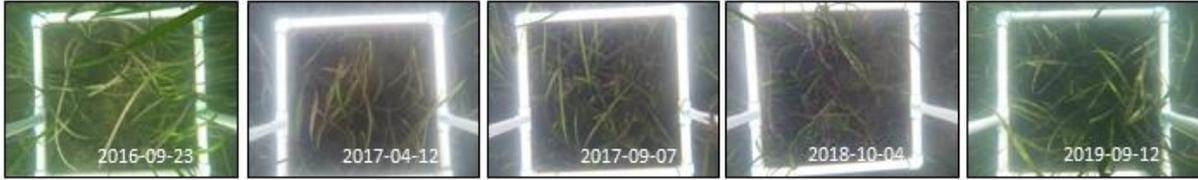
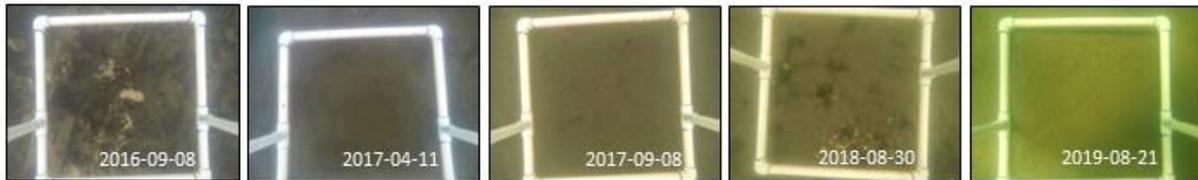
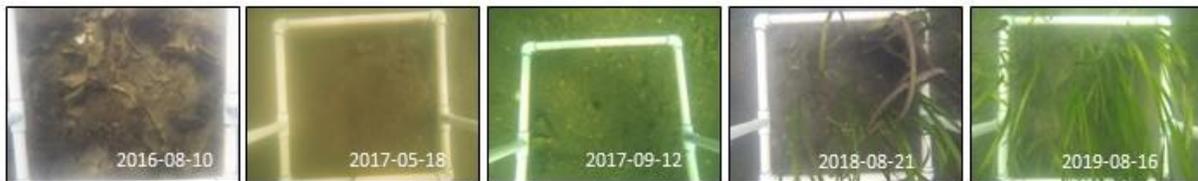
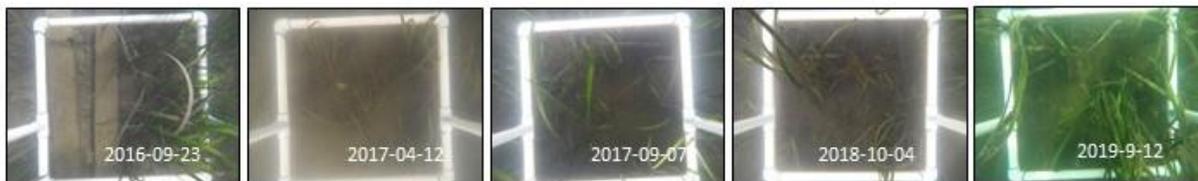
**Control Plots – Bed 22**

**Major Debris Plots – Rack 8S**

**Low Debris Plots – Rack 38C**

**Wood Plots - Rack 22G**

**Figure 3.** Representative images of photoplots pre, post, 1 year, 2 years, and 3 years after restoration from each of the four plot types. Images are generally from the same area of the transect except for 38C due to water clarity where Year 2 is from another section of the transect

We collected underwater imagery (stills) during snorkel surveys to quantify the percent cover of eelgrass and other community components (including debris and invasive species) underneath oyster racks (Fig. 3). However, videos were only collected during the pre-restoration surveys. Prior to image collection, a floating 50m line with markers every 5 m was placed between transect marker poles. The snorkeler then traveled along the transect line taking a quadrat image every 5m. Transect surveys were conducted during mid to low tides (generally < 3 ft) to allow snorkelers to access the estero floor with the camera quadrat. In eelgrass beds, the quadrat was placed just at the top of the eelgrass canopy and over non-eelgrass areas, the quadrat was held ~10-20 cm above the estero floor.

Data cleaning and QA/QC reduced the original percent cover dataset to 2,040 quadrat images from the 41 transects (control, major debris, low debris, and wood) collected under racks and adjacent control transects in nine of the twelve oyster rack areas (“beds”) where the original 95 oyster racks were located (Table 2). Sixty-two quadrats (3%) were omitted because they had > 9 “no data” points (out of 50) and 3 quadrats (0.1%) were removed due to an error giving them greater than 100% eelgrass cover. Omitted quadrats came almost entirely from pre-restoration control plots (Fig. B2). Representative images from each plot type during pre, post, and Years 1, 2, and 3 are shown in Figure 3.

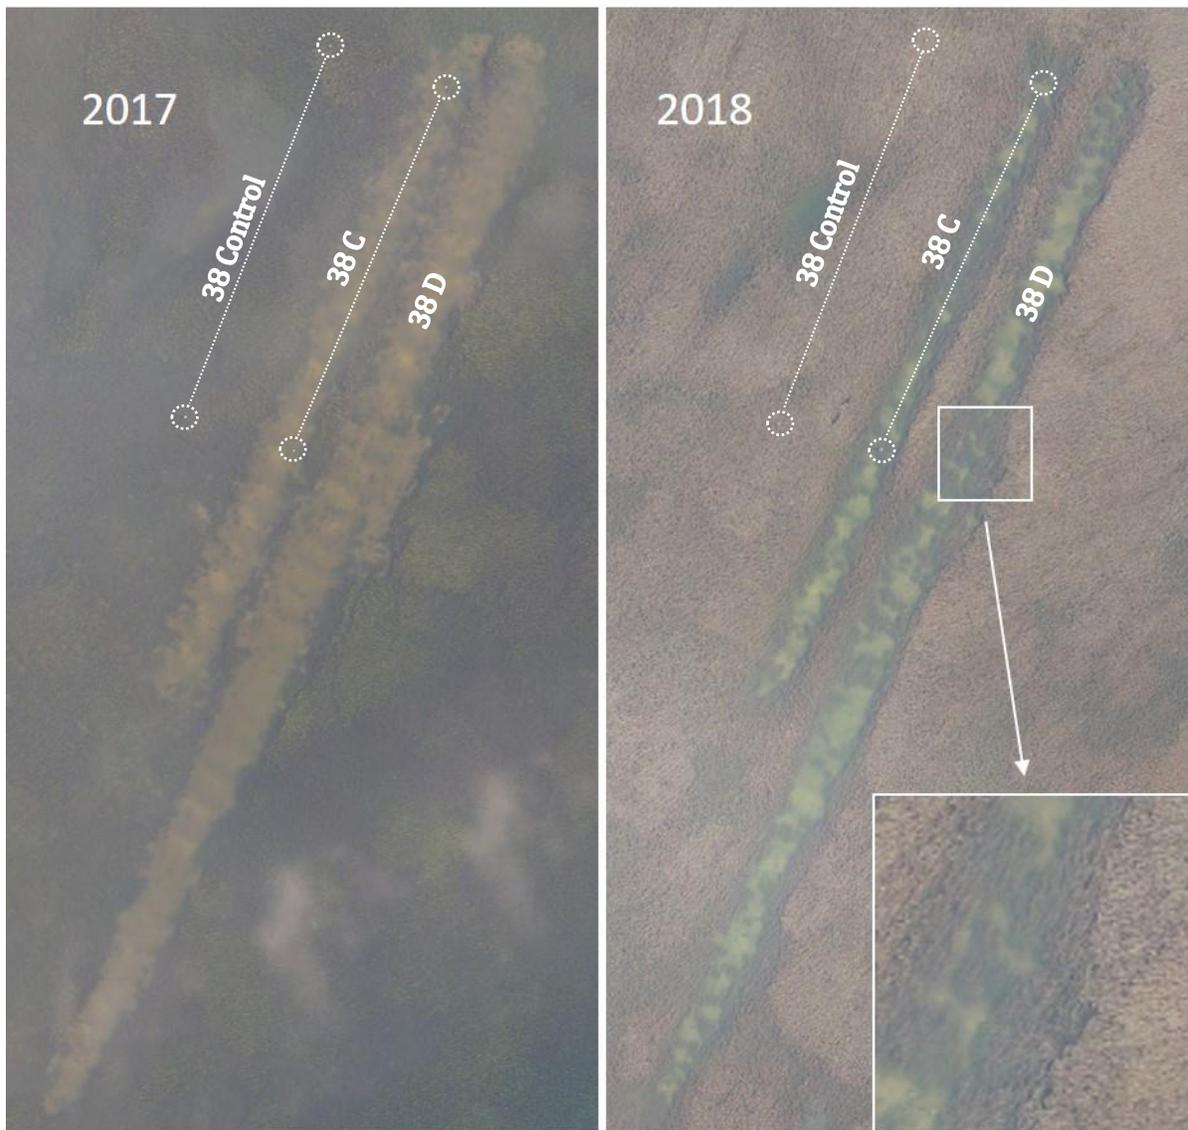
**Figure 7.** Aerial image examples of eelgrass regrowth from 2017 - 2018 in Bed 38 (Home Bay) for rack 38C and D. The left panel (2017) shows racks approximately 6 months after rack and bottom debris removal. The right panel (2018) shows patches of eelgrass growing into the removal areas. Inset (bottom right) shows close up of eelgrass (species confirmed by high resolution imagery and field observations) growing into bare patches. In this example, only rack 38C (left rack) was monitored with snorkel surveys (Table 1, Fig. 2B). 2019 imagery is still being processed.

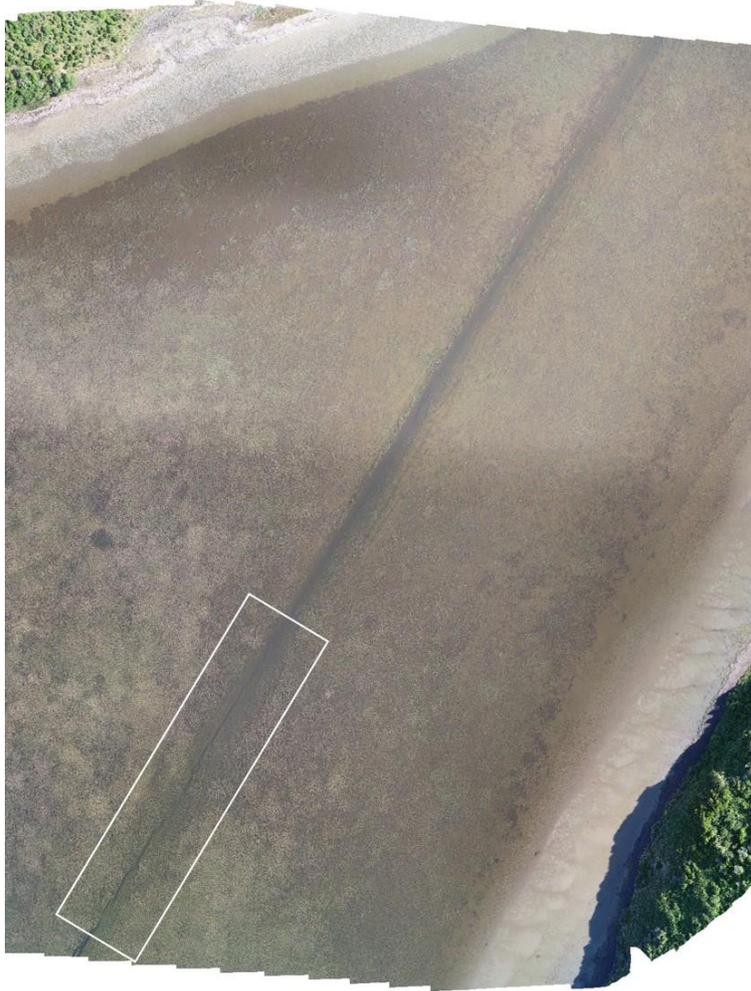
**Figure 8.** Summer 2018 image of Schooner Bay boating channel showing growth of eelgrass in box, nearly eliminating the channel. Summer 2019 imagery is still being processed.

We also noted additional evidence for eelgrass regrowth in the main boating channel from the former oyster facility to the center of Home Bay. In 2018, much of the channel appears to have narrowed considerably with eelgrass filling in along the edges. We do not yet have 2017-2019 comparison imagery, but a narrowing of the channel with eelgrass infill during 2018 is shown in Fig. 8 and this is corroborated by our on the water observations.
