# ANSEL ADAMS GALLERY COMPLEX REHABILITATION

ENVIRONMENTAL ASSESSMENT  
APRIL 2014

# **Ansel Adams Gallery Complex Rehabilitation Environmental Assessment**

**Yosemite National Park  
National Park Service**

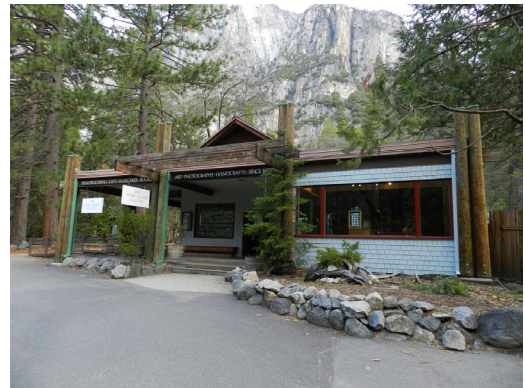
**Building 900A**

- An existing ramp with handrails was built to make the Gallery main entrance accessible, but this access does not adequately meet park policy.
- The south entrance threshold from the Gallery porch exceeds variance restrictions.
- The lower retail level is approximately 16 inches higher than the upper retail level.
- The Gallery's west entrance door swings opposite of the direction of exit travel.
- There is no accessible employee restroom. (The closest accessible restroom is in the public restrooms located to the west, between the Visitor Center and Museum.)

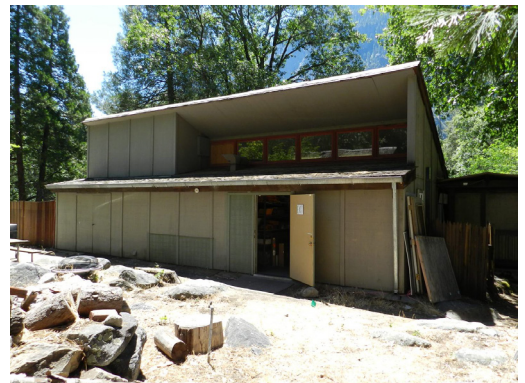
**Building 901**

- There is no accessible path of travel from a parking area to an entrance door.
- There is no accessible restroom.

*Darkroom (Building 901)* — Structurally, the Darkroom is in good condition. There are instances of insect or bird-related damage to the siding and roof fascia, but the framing does not appear to have been compromised.

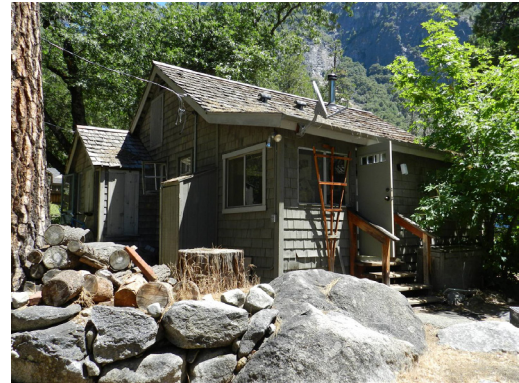
**Building 902**

*Duplex (Building 902)* — The Duplex residence is structurally in fair condition, although poor grade separation at the exterior, particularly at the north and east walls, has led to some deterioration of foundation posts, floor beams, floor joists, and wall framing. There is a small separation at the interface between the wall and ceiling at the west wall, a moderate floor slope at the northeast bedroom, and rot at the base of the stair stringers at the south entrance. Several foundation posts near the southwest corner of the building are leaning.

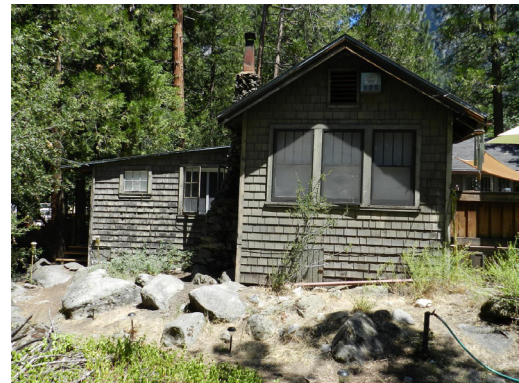
**Building 904**

*Upper Residence (Building 904)* — Building 904 is in fair condition. Poor grade separation at the north wall and north end of the east and west walls has contributed to deterioration of the floor and wall framing at these locations. There is a dramatic floor slope in both kitchens and decay was observed in fascia boards, roof sheathing, and a rafter tail. Several foundation posts are leaning. There is insect damage at the interior wall adjacent to the north kitchen, which includes significant damage to the wall sheathing and possible damage to the studs. At the time of the structural survey, the exterior stair and deck at the west elevation were substantially deteriorated.
