Bridalveil Fall Rehabilitation Environmental Assessment

BRIDALVEIL FALL REHABILITATION ENVIRONMENTAL ASSESSMENT

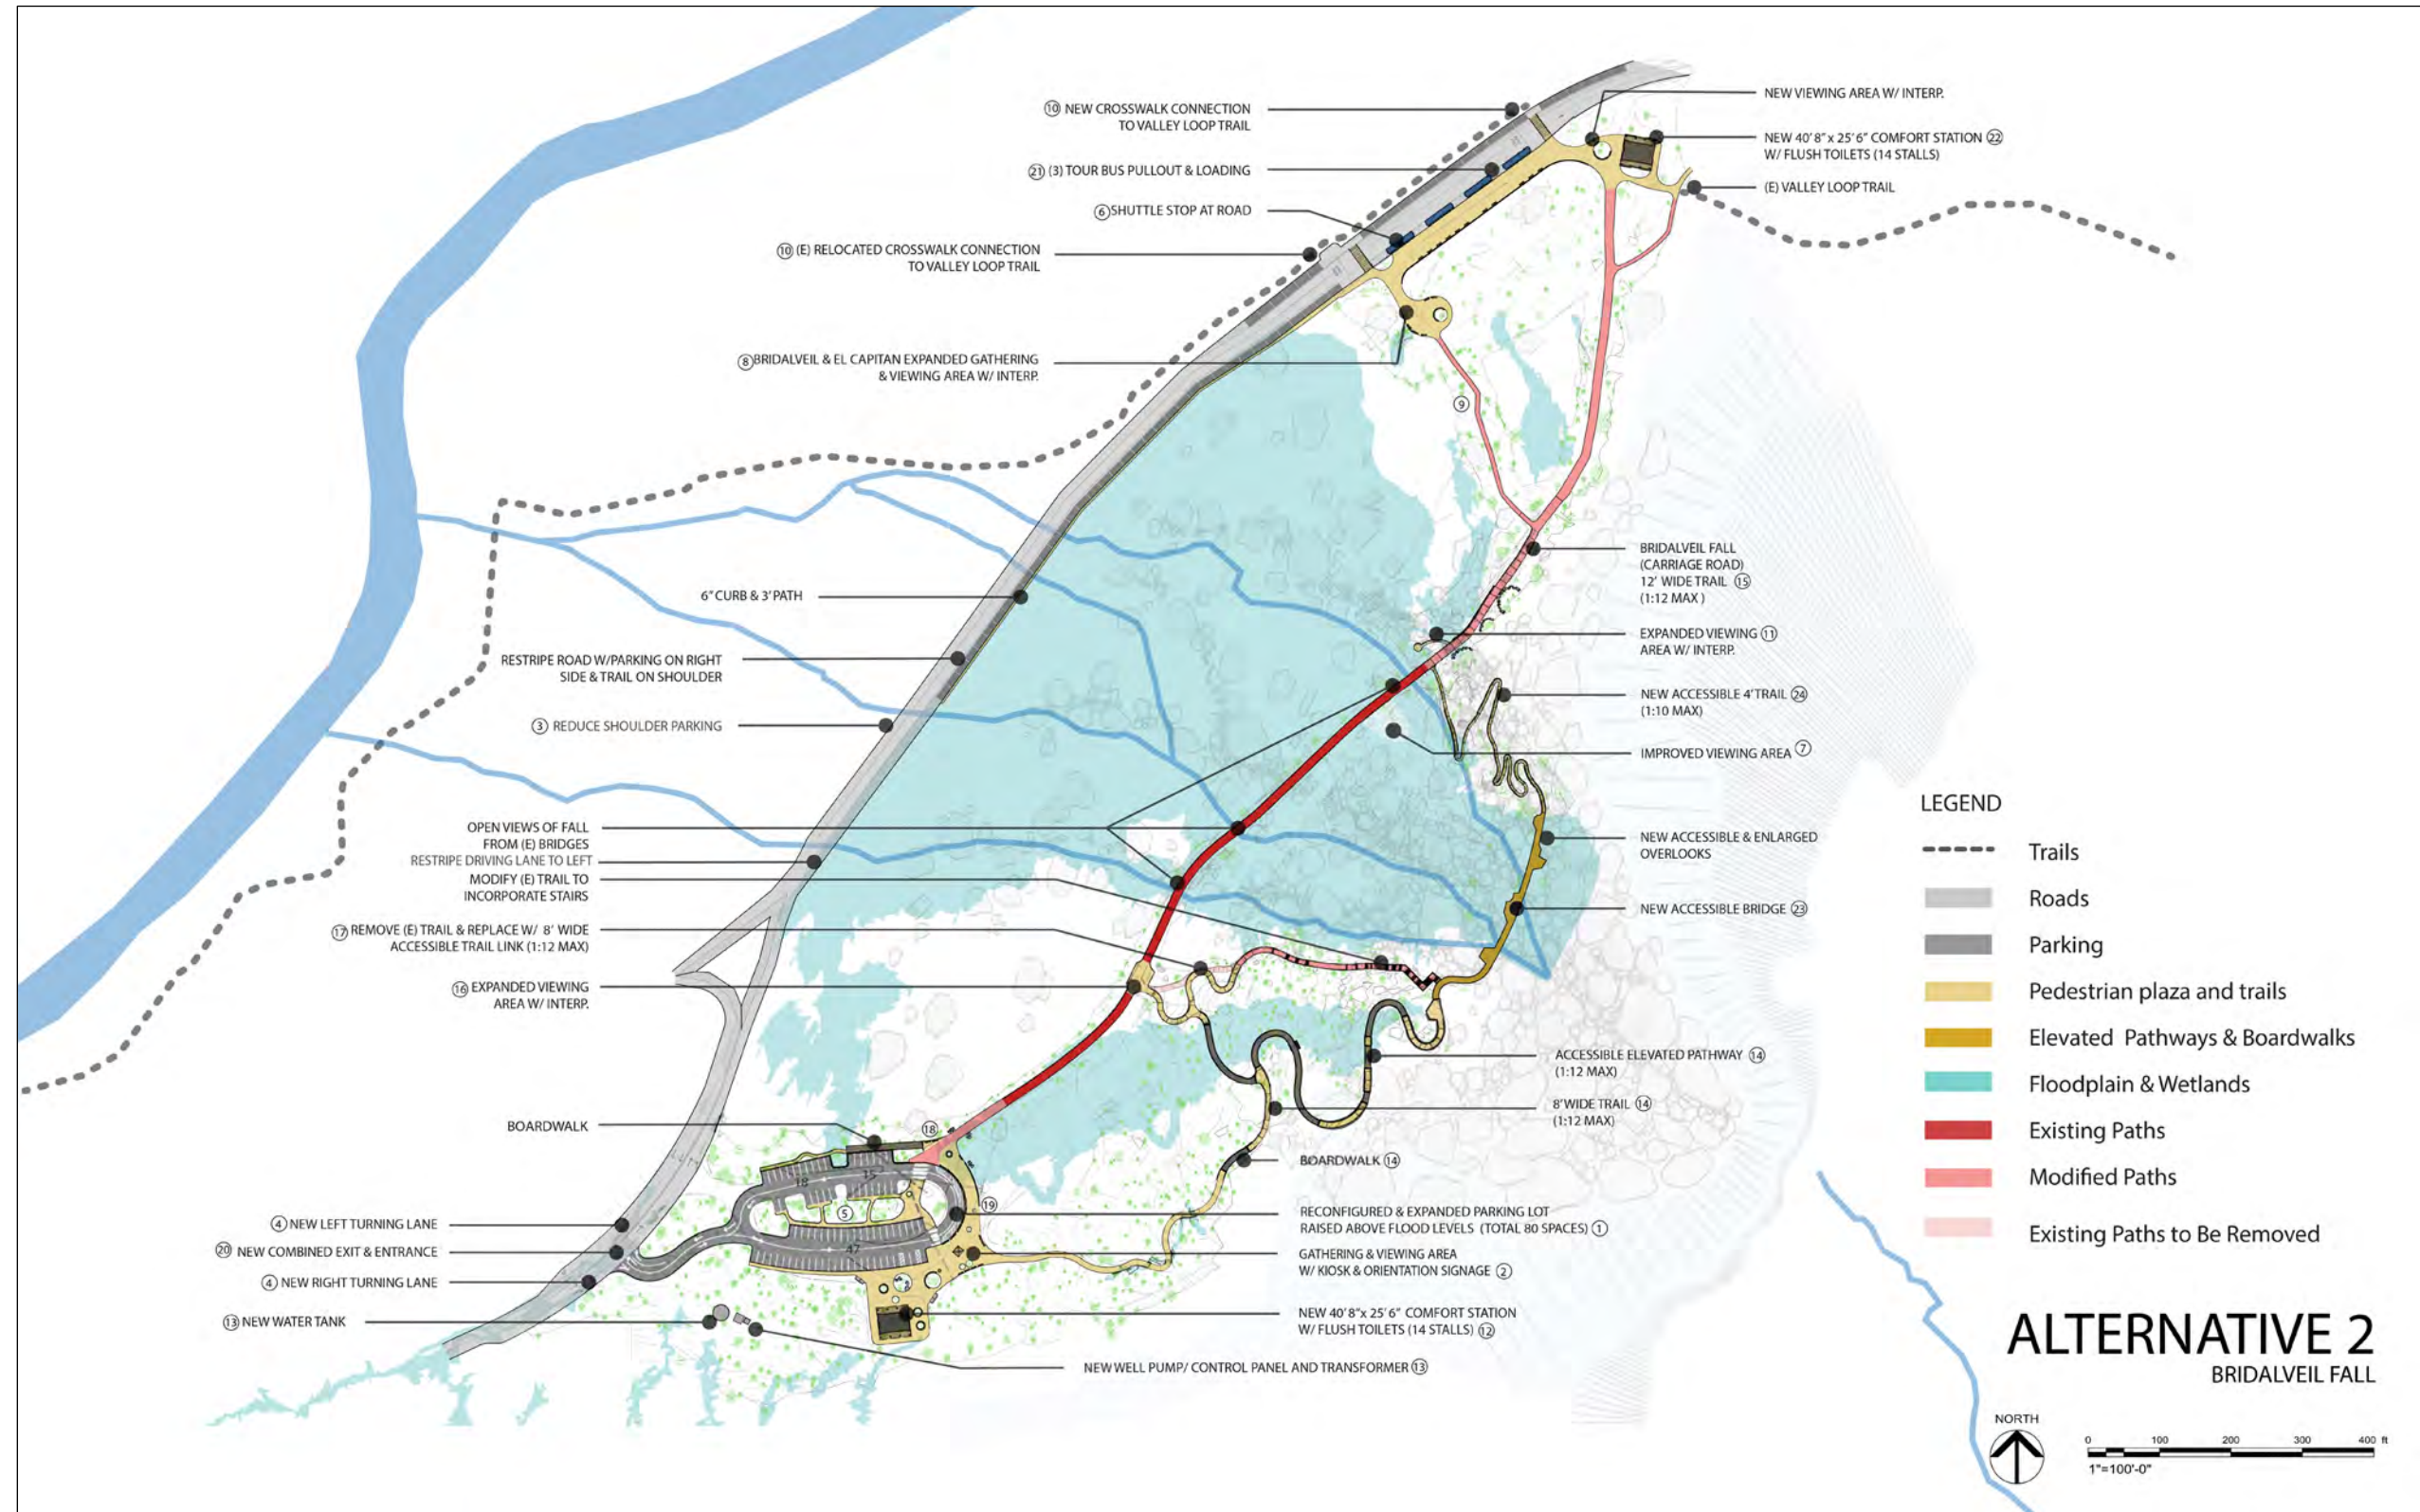
Figure 2-2. Alternative 2

Note: Numbers on map correspond to numbers in Tables 2-2 and 2-3.

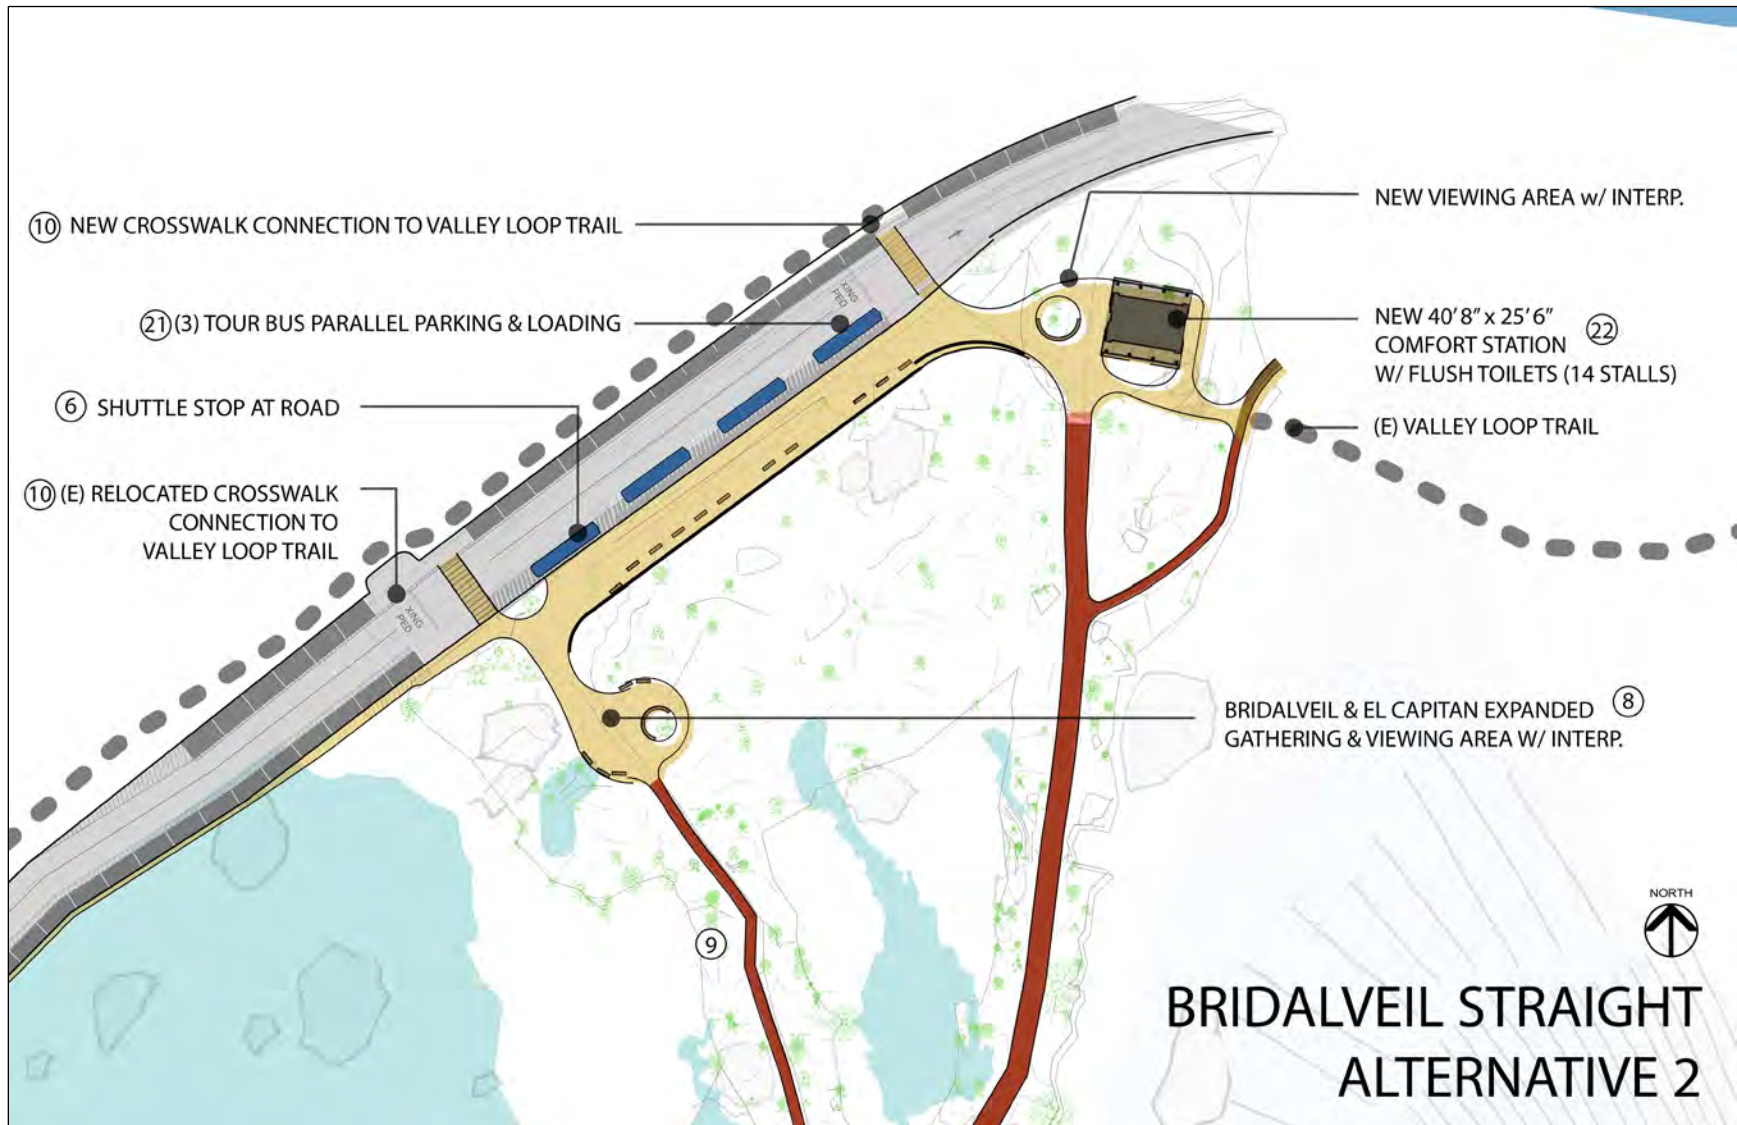
Figure 2-4. Bridalveil Straight Alternative 2

Note: Numbers on map correspond to numbers in Tables 2-2 and 2-3.

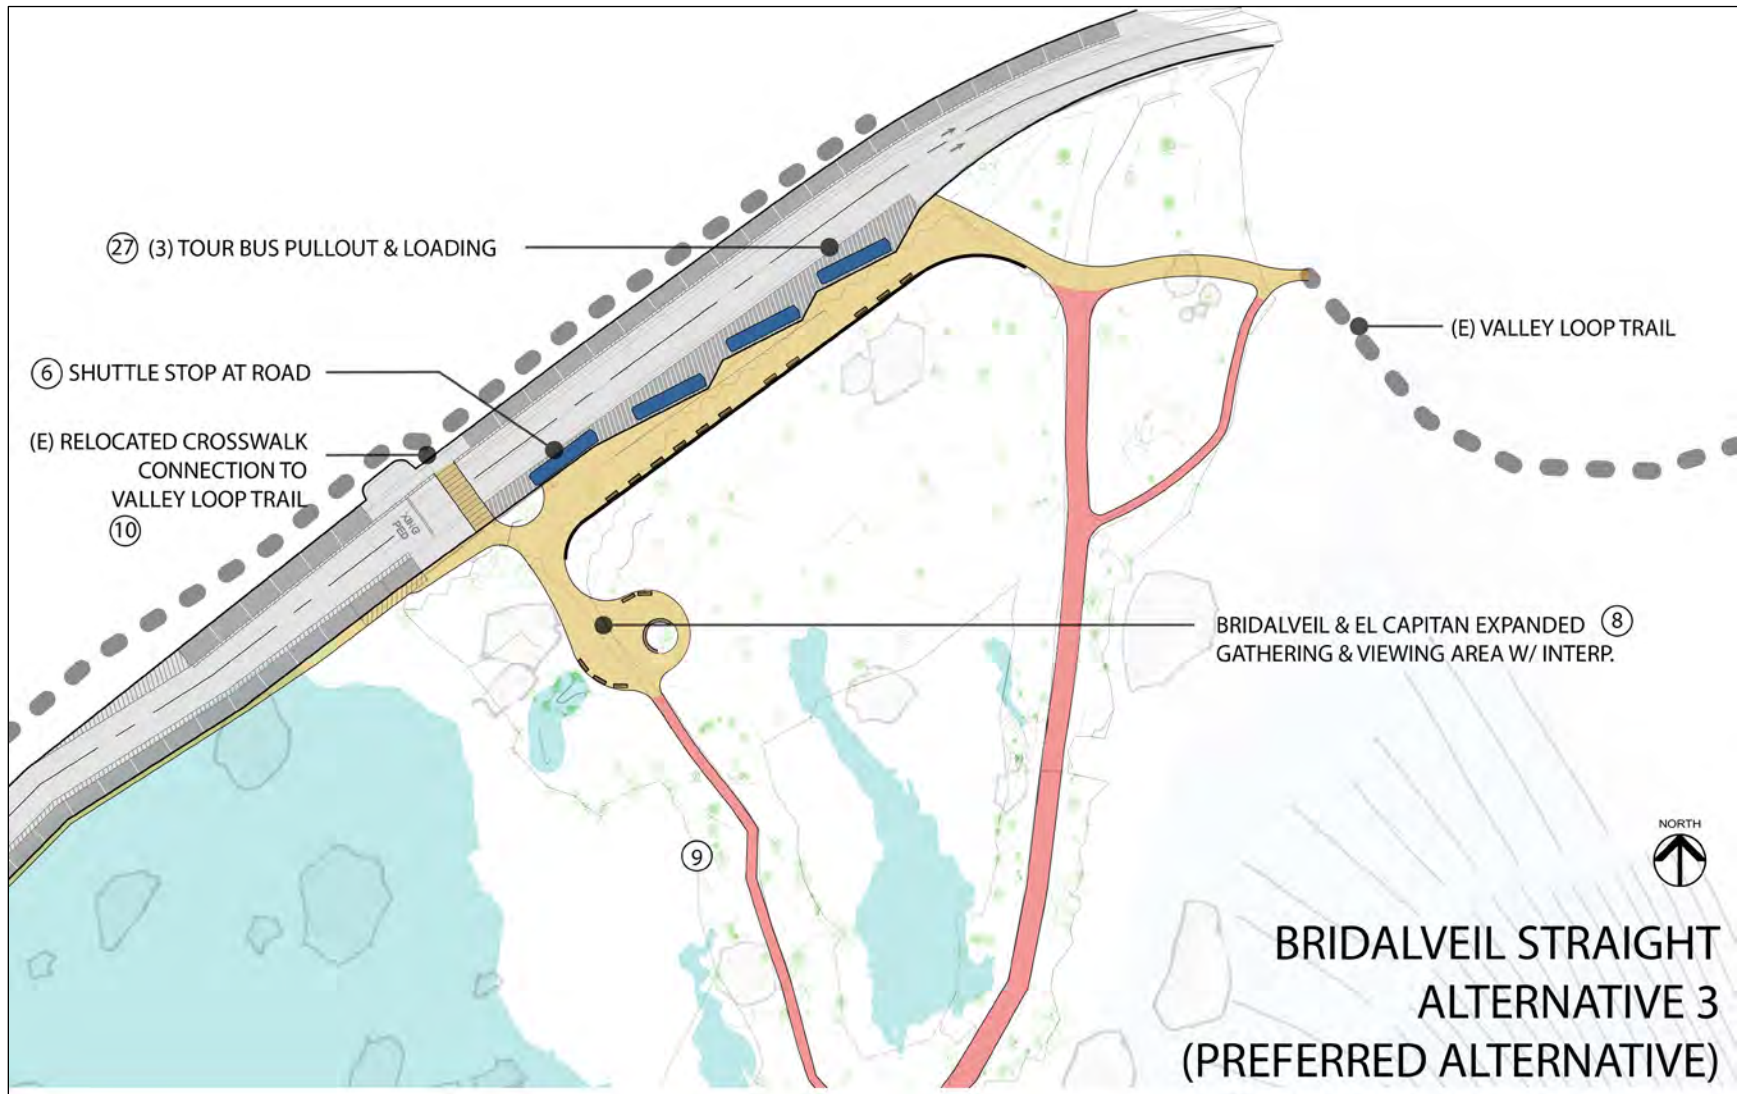
Figure 2-5. Bridalveil Straight Alternative 3

Note: Numbers on map correspond to numbers in Tables 2-2 and 2-3.

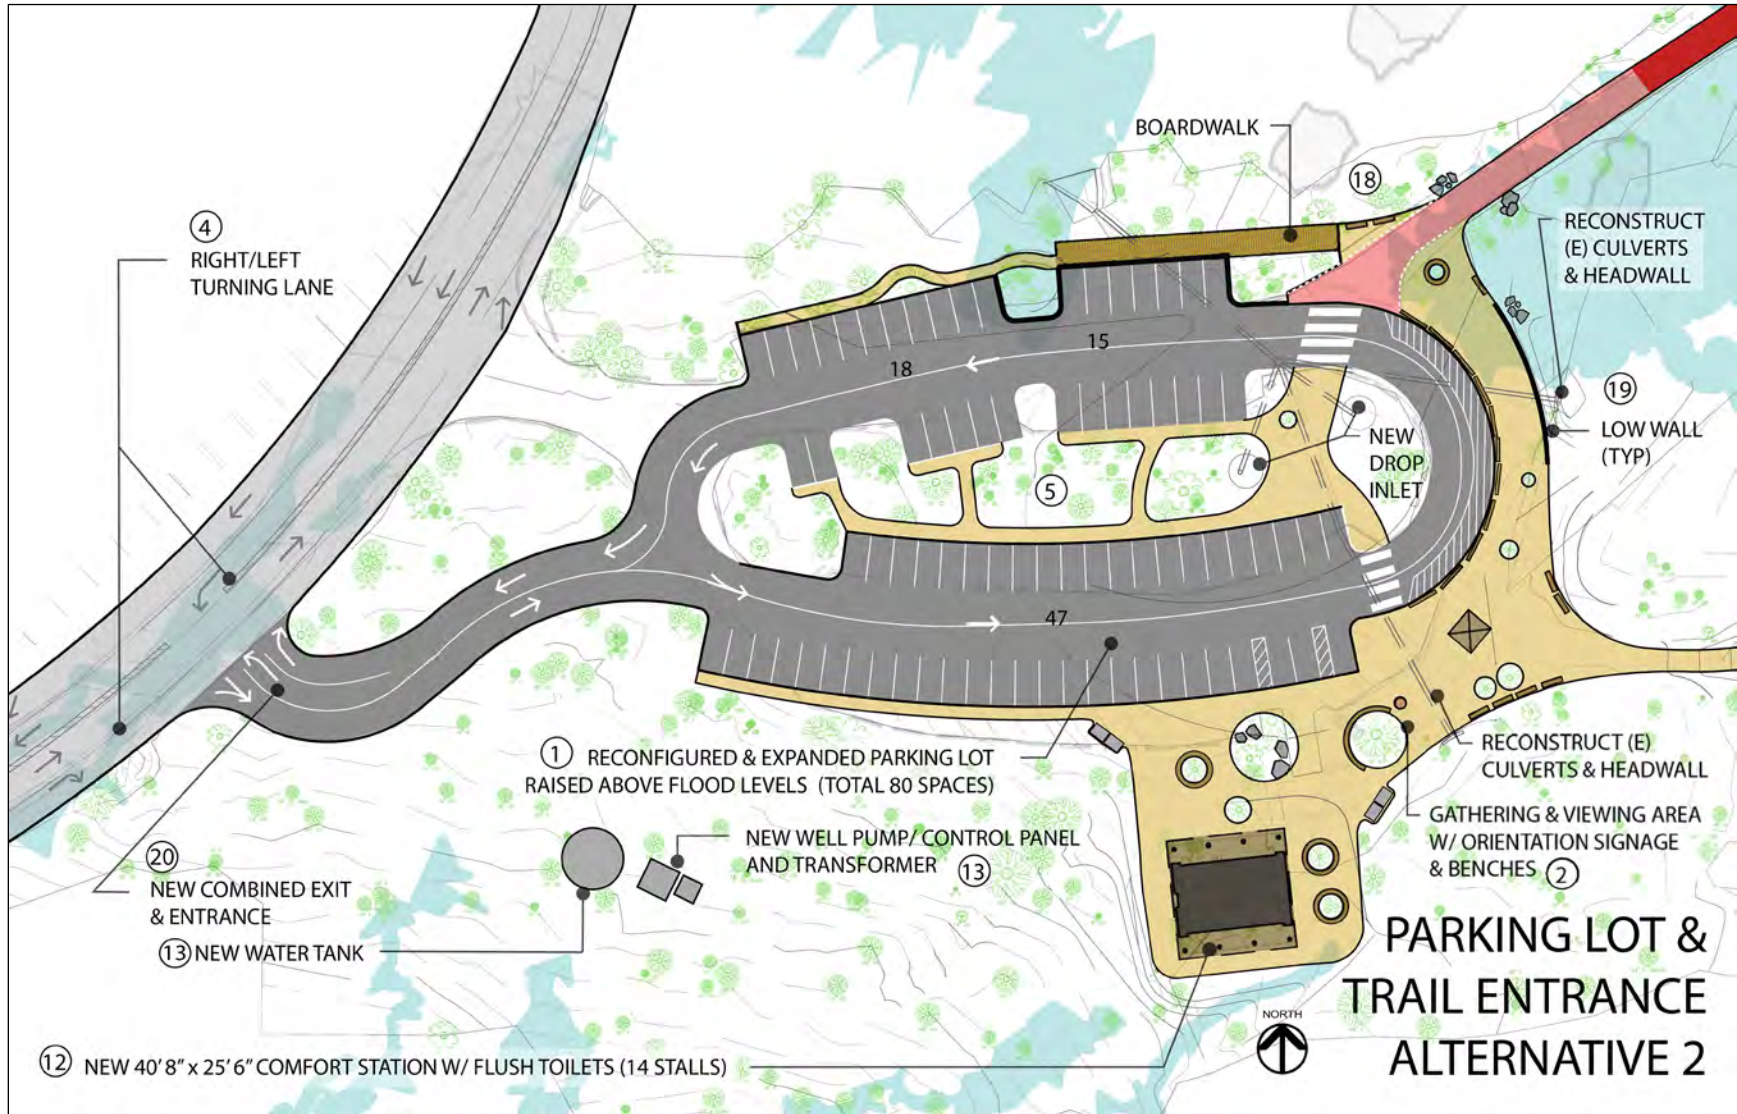
Figure 2-6. Parking Lot and Trail Entrance Alternative 2

Note: Numbers on map correspond to numbers in Tables 2-2 and 2-3.

Under Alternative 2, a new combined entrance and exit road to the parking lot would replace the existing entrance/exit road approximately 150 feet south of the existing entrance/exit (20). An island would be added to separate the exit and entrance lanes and there would be separate exit lanes for right-hand and left-hand turns.

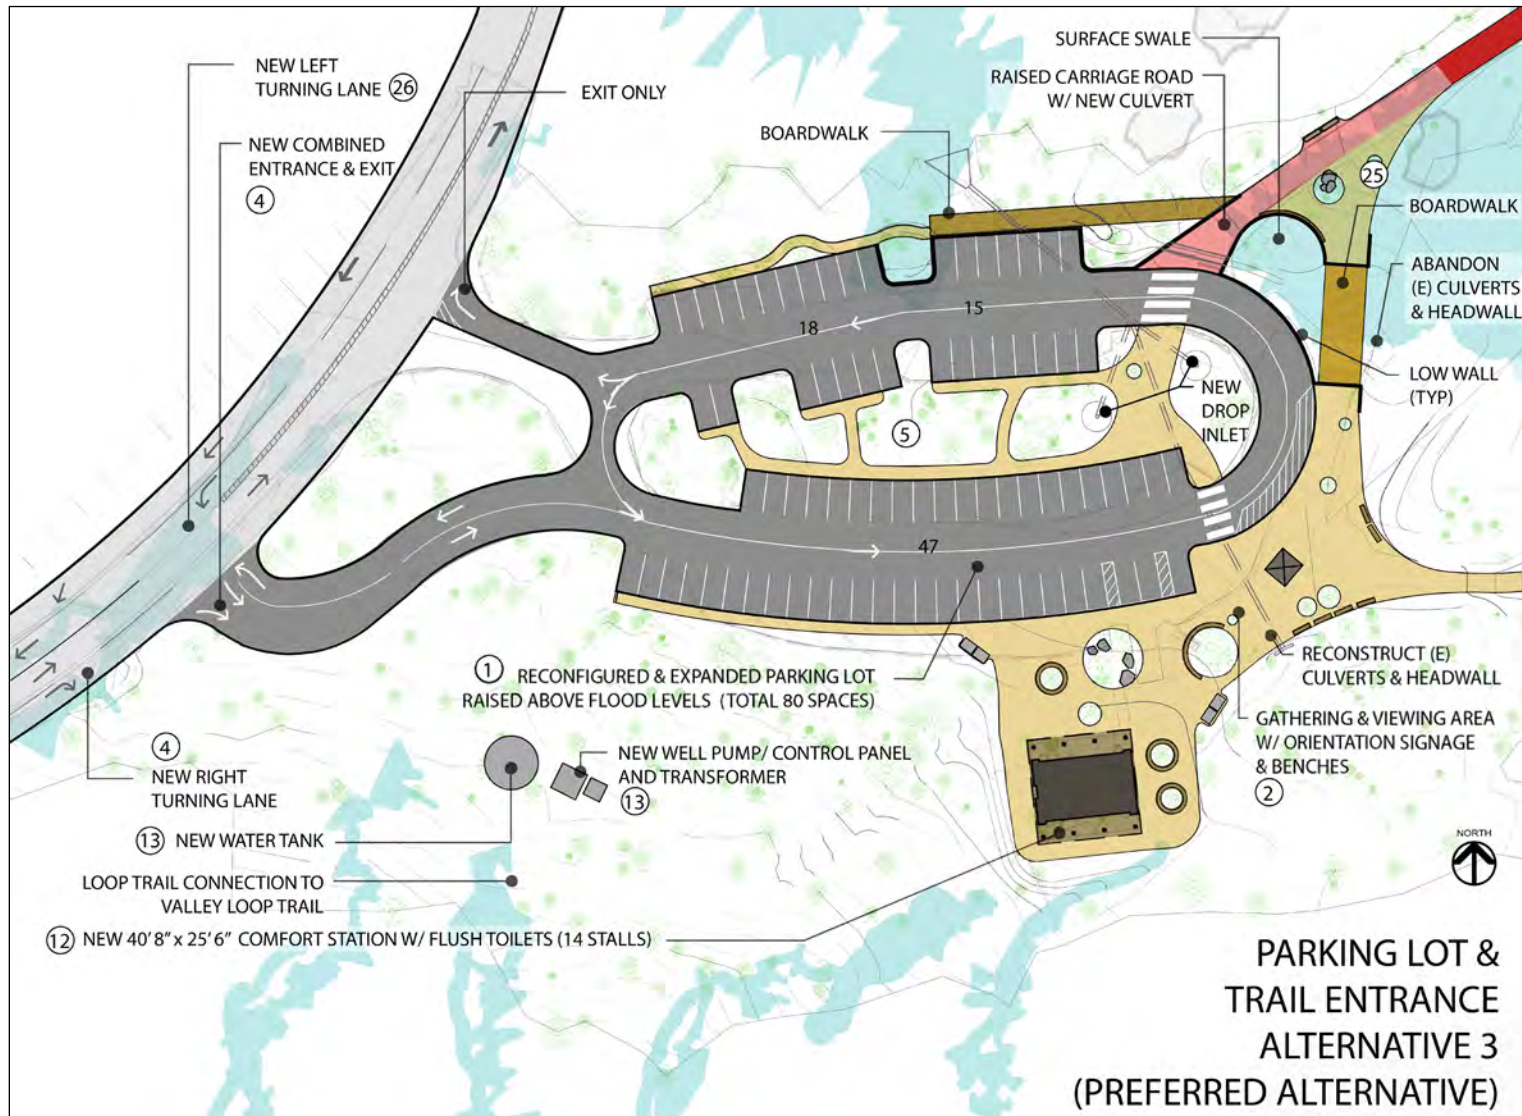
Figure 2-7. Parking Lot and Trail Entrance Alternative 3

Note: Numbers on map correspond to numbers in Tables 2-2 and 2-3.

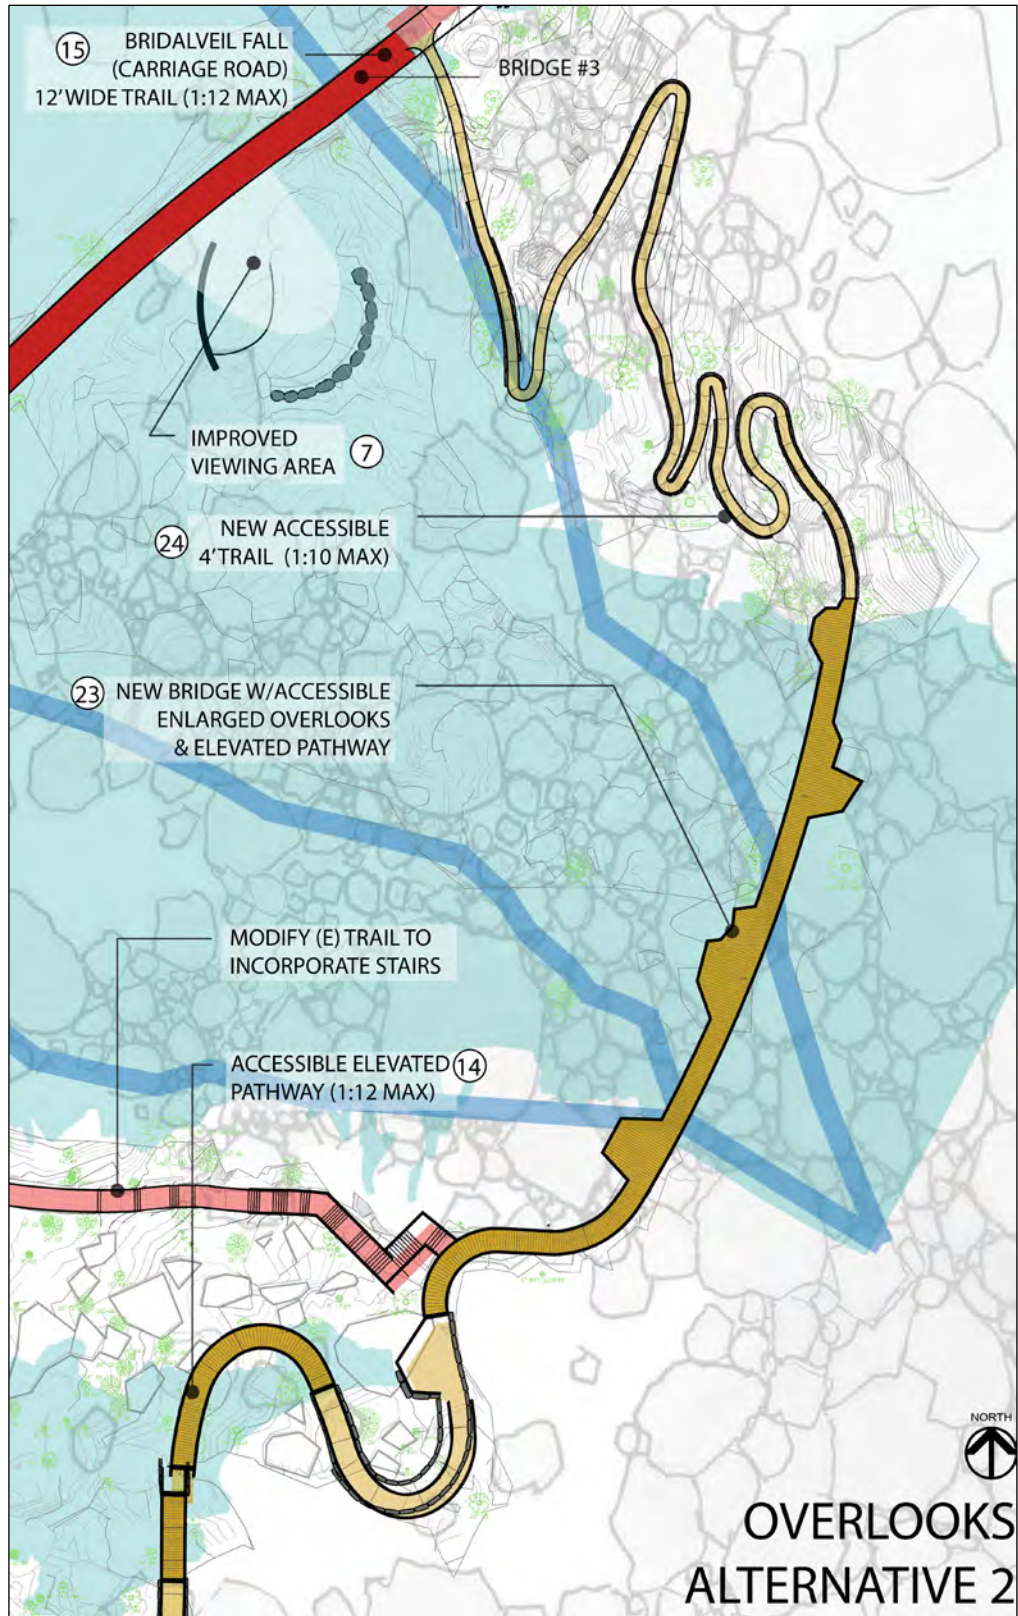
Figure 2-8. Overlooks Alternative 2

Note: Numbers on map correspond to numbers in Tables 2-2 and 2-3.

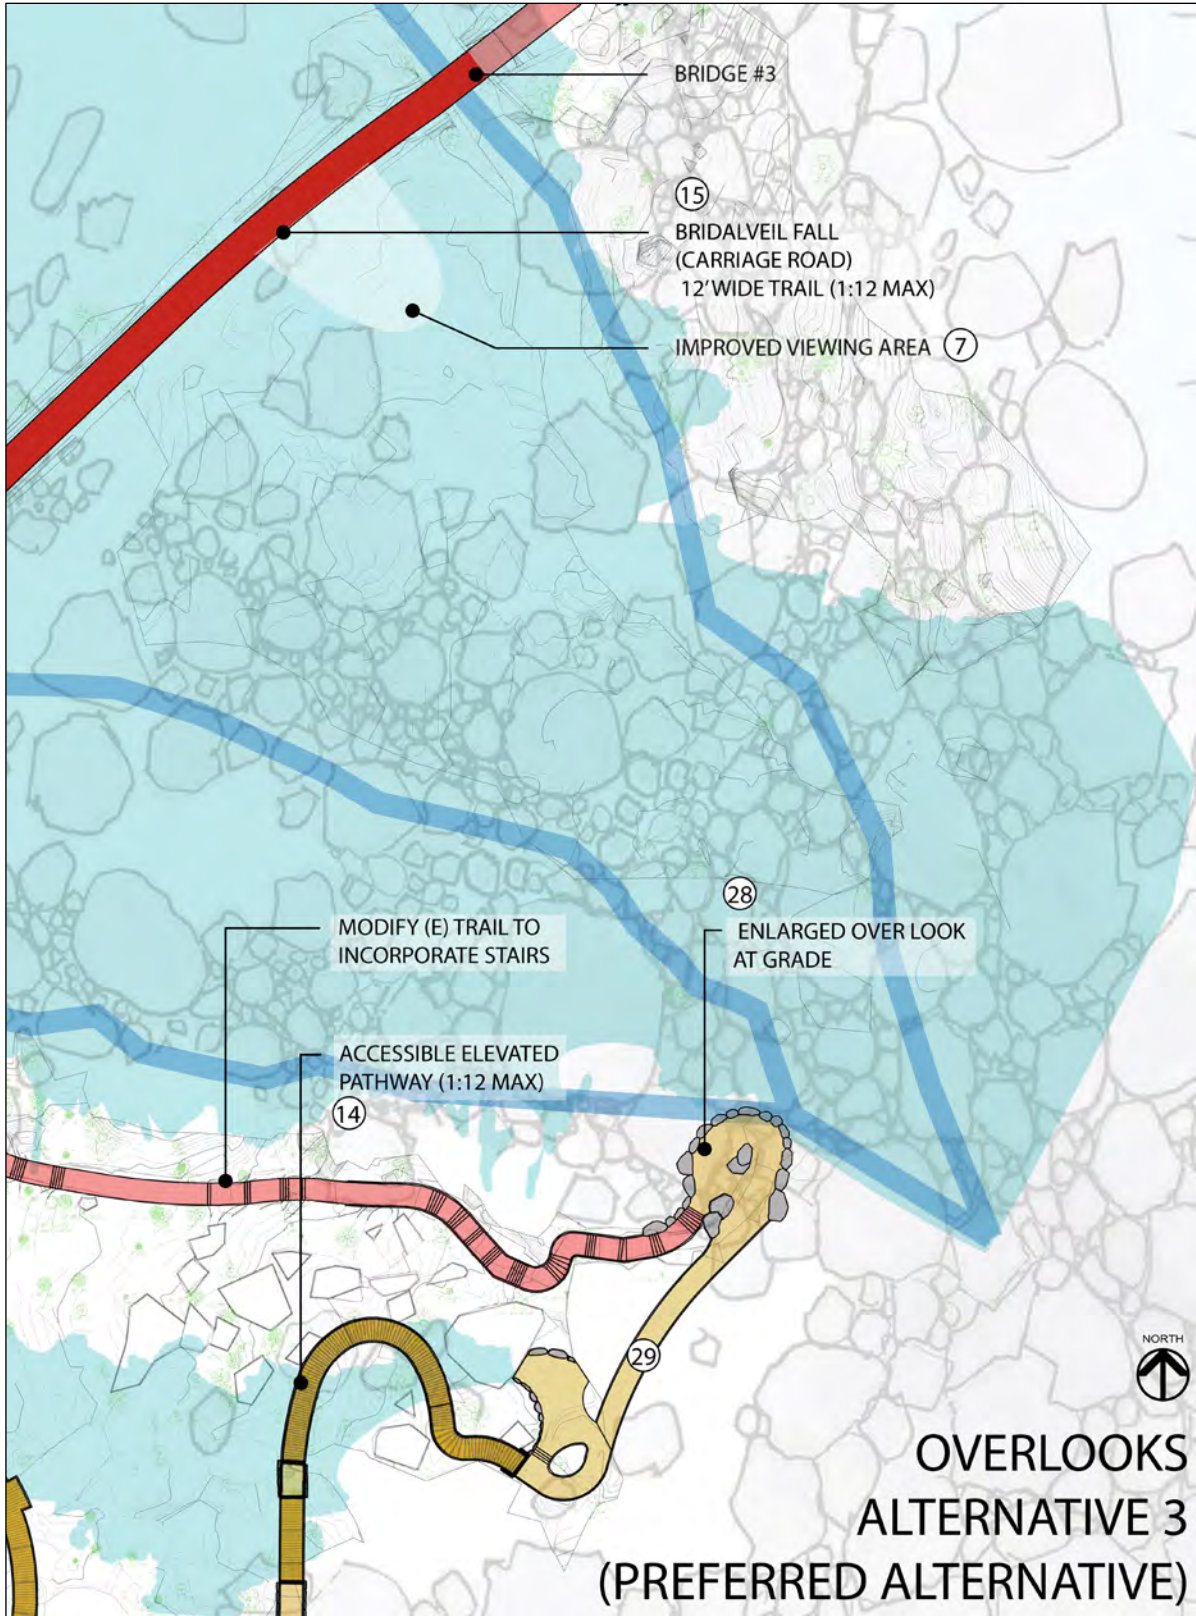
Figure 2-9. Overlooks Alternative 3

Note: Numbers on map correspond to numbers in Tables 2-2 and 2-3.

Under Alternative 3, the existing viewing platform at the base of Bridalveil Fall would expand from 400 square feet to approximately 1,500 square feet (28). The viewing platform would be replaced and expanded in its current location. The new viewing platform would be constructed of robust materials suitable for the site conditions. The finished elevation of the new viewing platform surface would be between 4 inches and 18 inches above the existing viewing platform. A safety railing would be installed at the edge of the overlook. In addition to the new viewing platform that would be constructed on the new

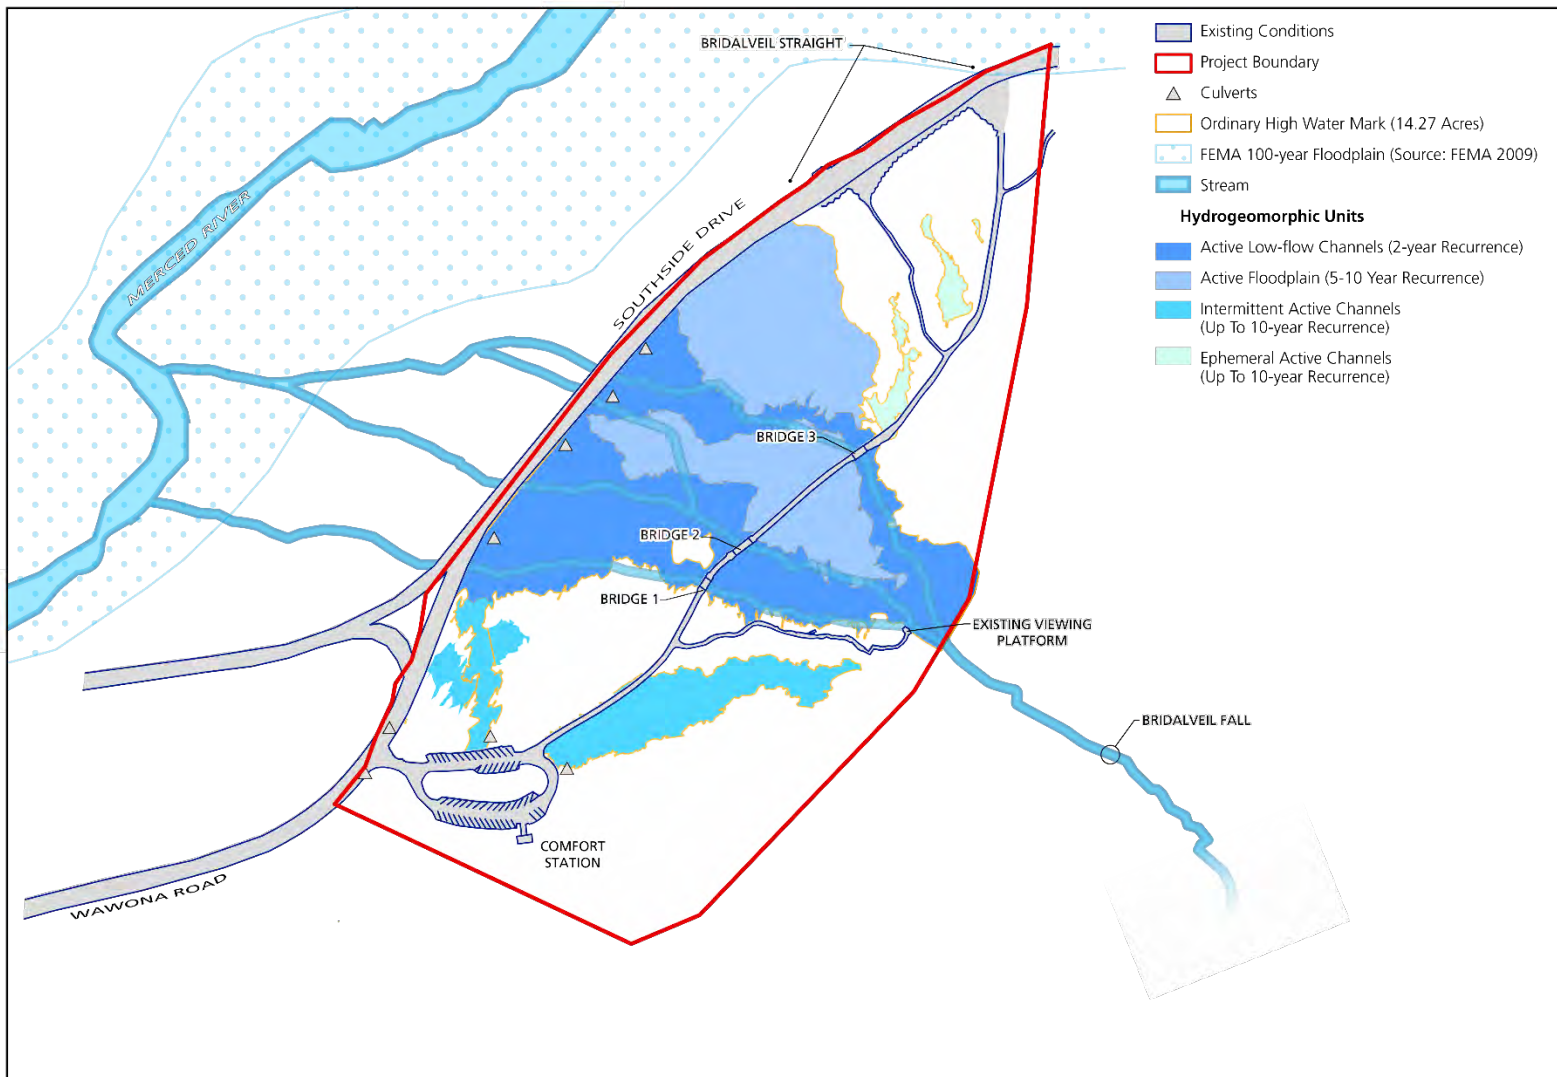
Figure 3-1. Hydrogeomorphic Units within the Project Area

Hydrogeomorphic Units within the Project Area
 Bridalveil Fall Rehabilitation
 United States Department of the Interior/National Park Service

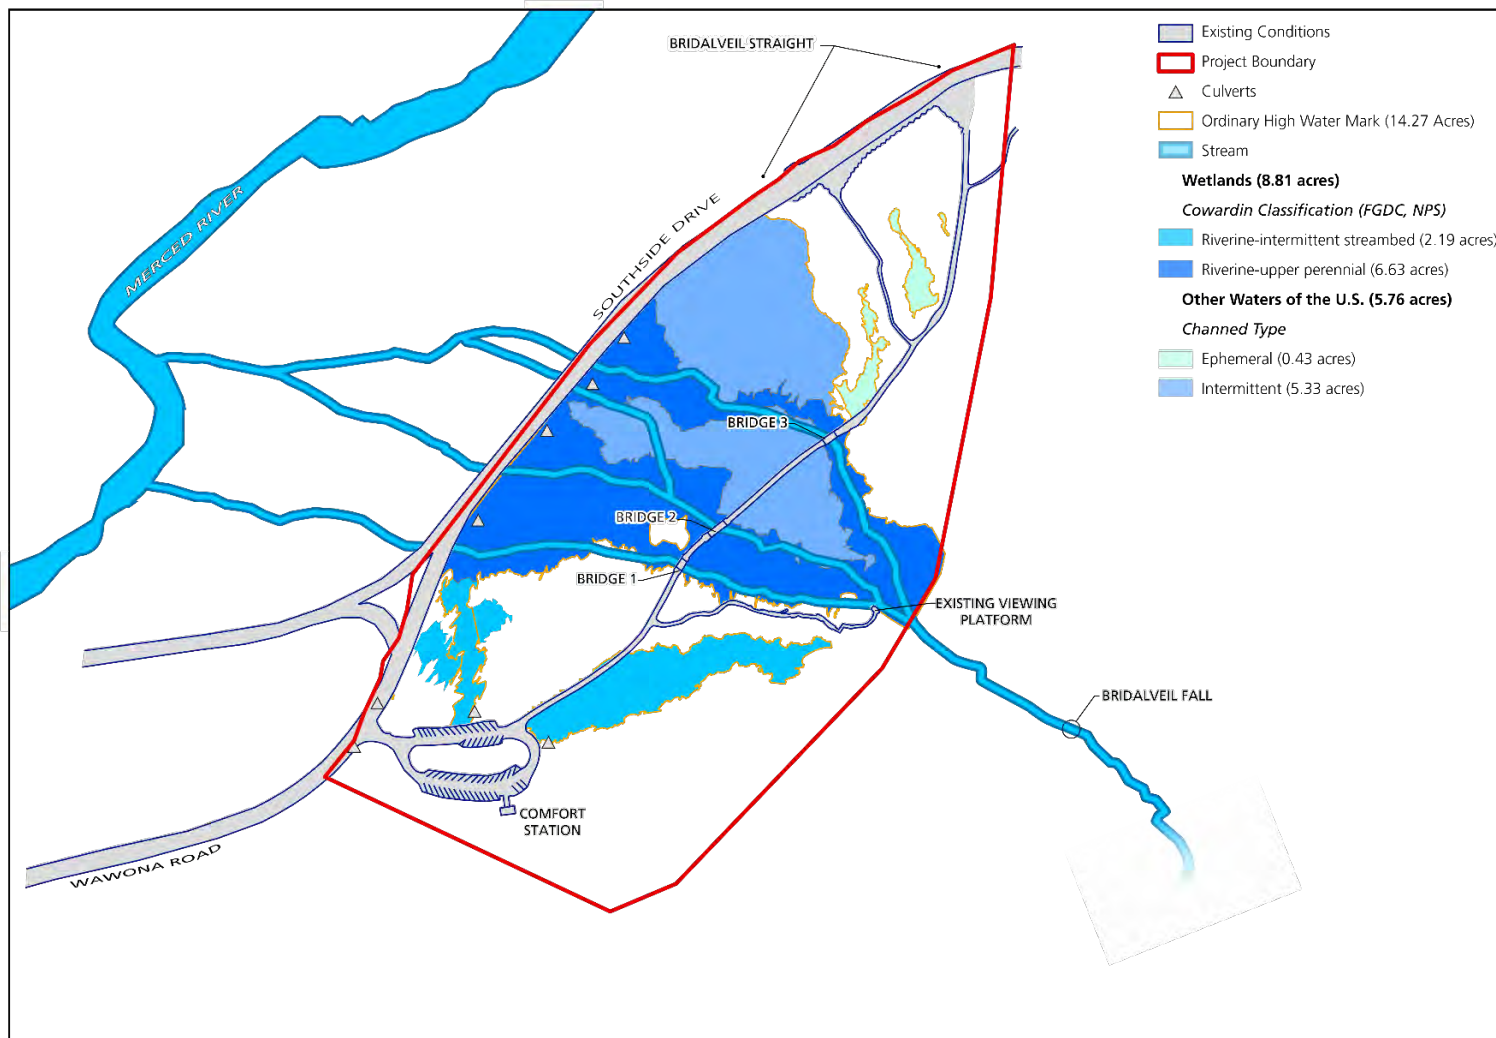
Figure 3-3. Wetlands within the Project Area

The Bridalveil Fall project area is a dynamic wetland area with 8.81 acres of wetland features including the braided stream channel of Bridalveil Creek (Riverine Upper Perennial Streambed wetland) and Riverine Intermittent Streambed wetlands that flow in and out of the northeast corner of the parking lot area. There are also channels that flow less often that the USACE considers Intermittent Other Waters of the U.S. and Ephemeral Other Waters of the U.S. (5.76 acres) (Figure 3-3). Two hydrophytic plant species were identified within the ordinary high water mark for many mapped features (white alder [*Alnus rhombifolia*] and California bay laurel [*Umbellularia californica*]). Soils in the area are classified as mollic xerofluvents (young hydric soils with shallow organic horizons).

Wetlands within the Project Area
 Bridalveil Fall Rehabilitation
 United States Department of the Interior/National Park Service

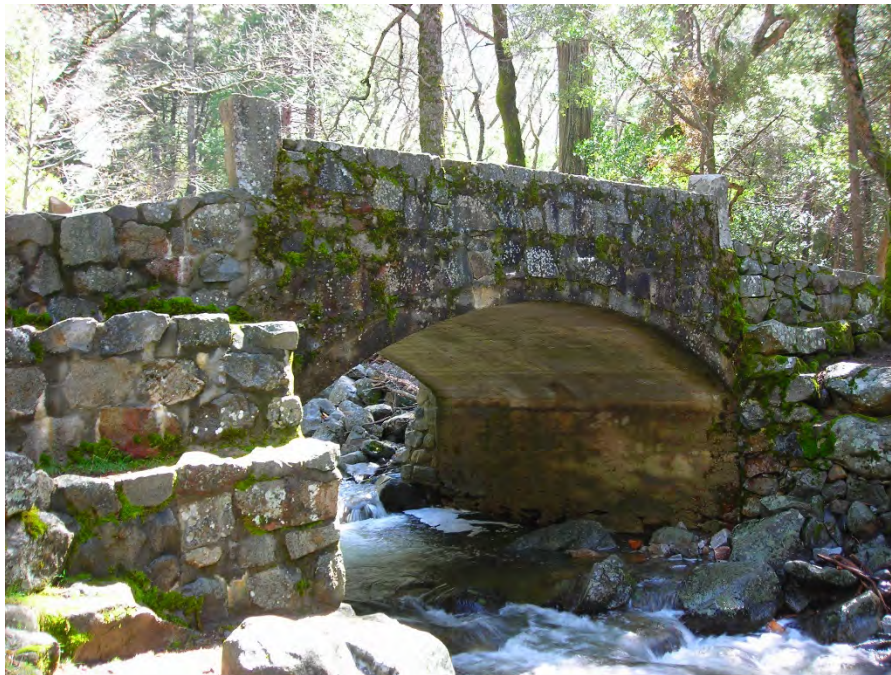
BRIDGE 3

Park (Quin 1991). One of the pylons on Bridge Number 1 is missing, but no other major deterioration is evident.

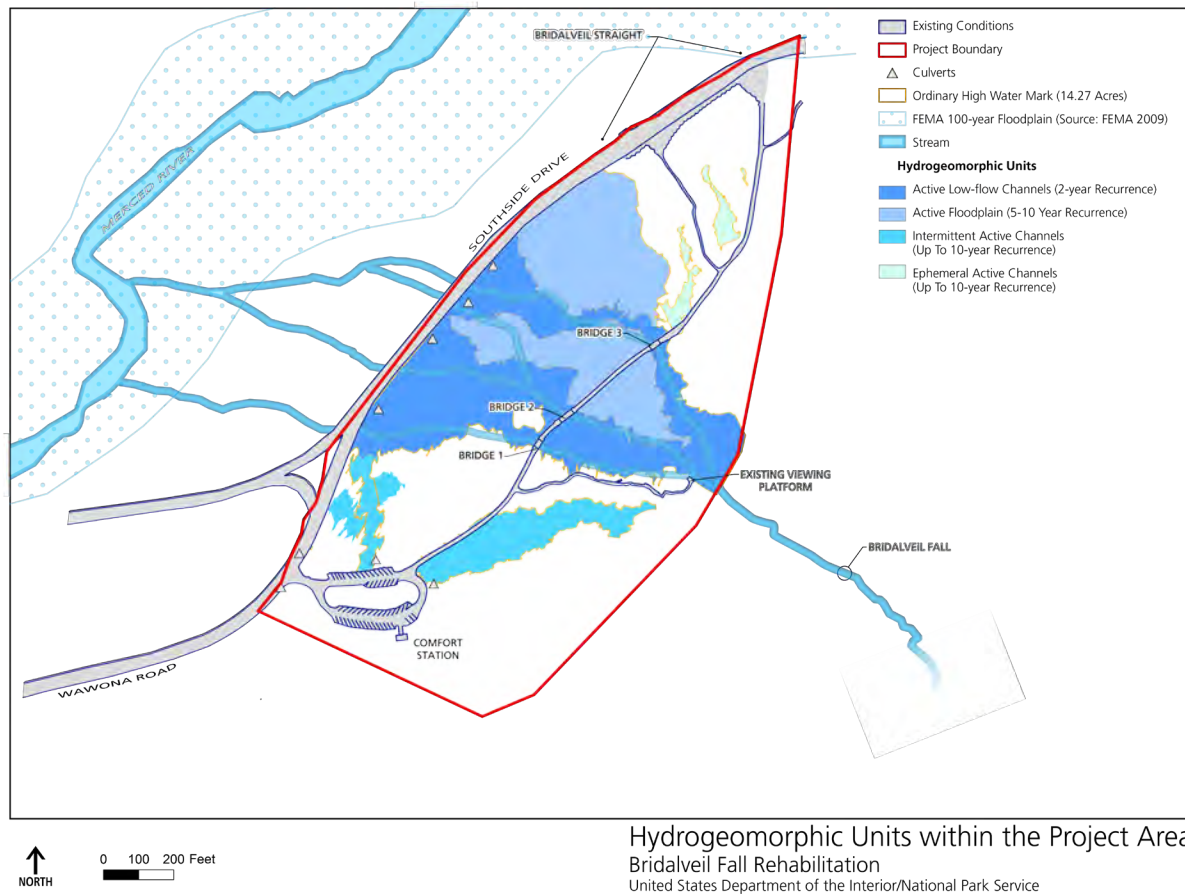
Figure 1. Hydrogeomorphic Units in the Bridalveil Fall Project Area

The gradient of Bridalveil Creek decreases as it reaches the edge of the project area at Southside Drive. The project area does not include the confluence of Bridalveil Creek with the Merced River, which is approximately 600 feet downstream of the project area boundary (Figure 1). The northernmost tip of the Bridalveil Fall project area is located within the 100-year floodplain of the Merced River.

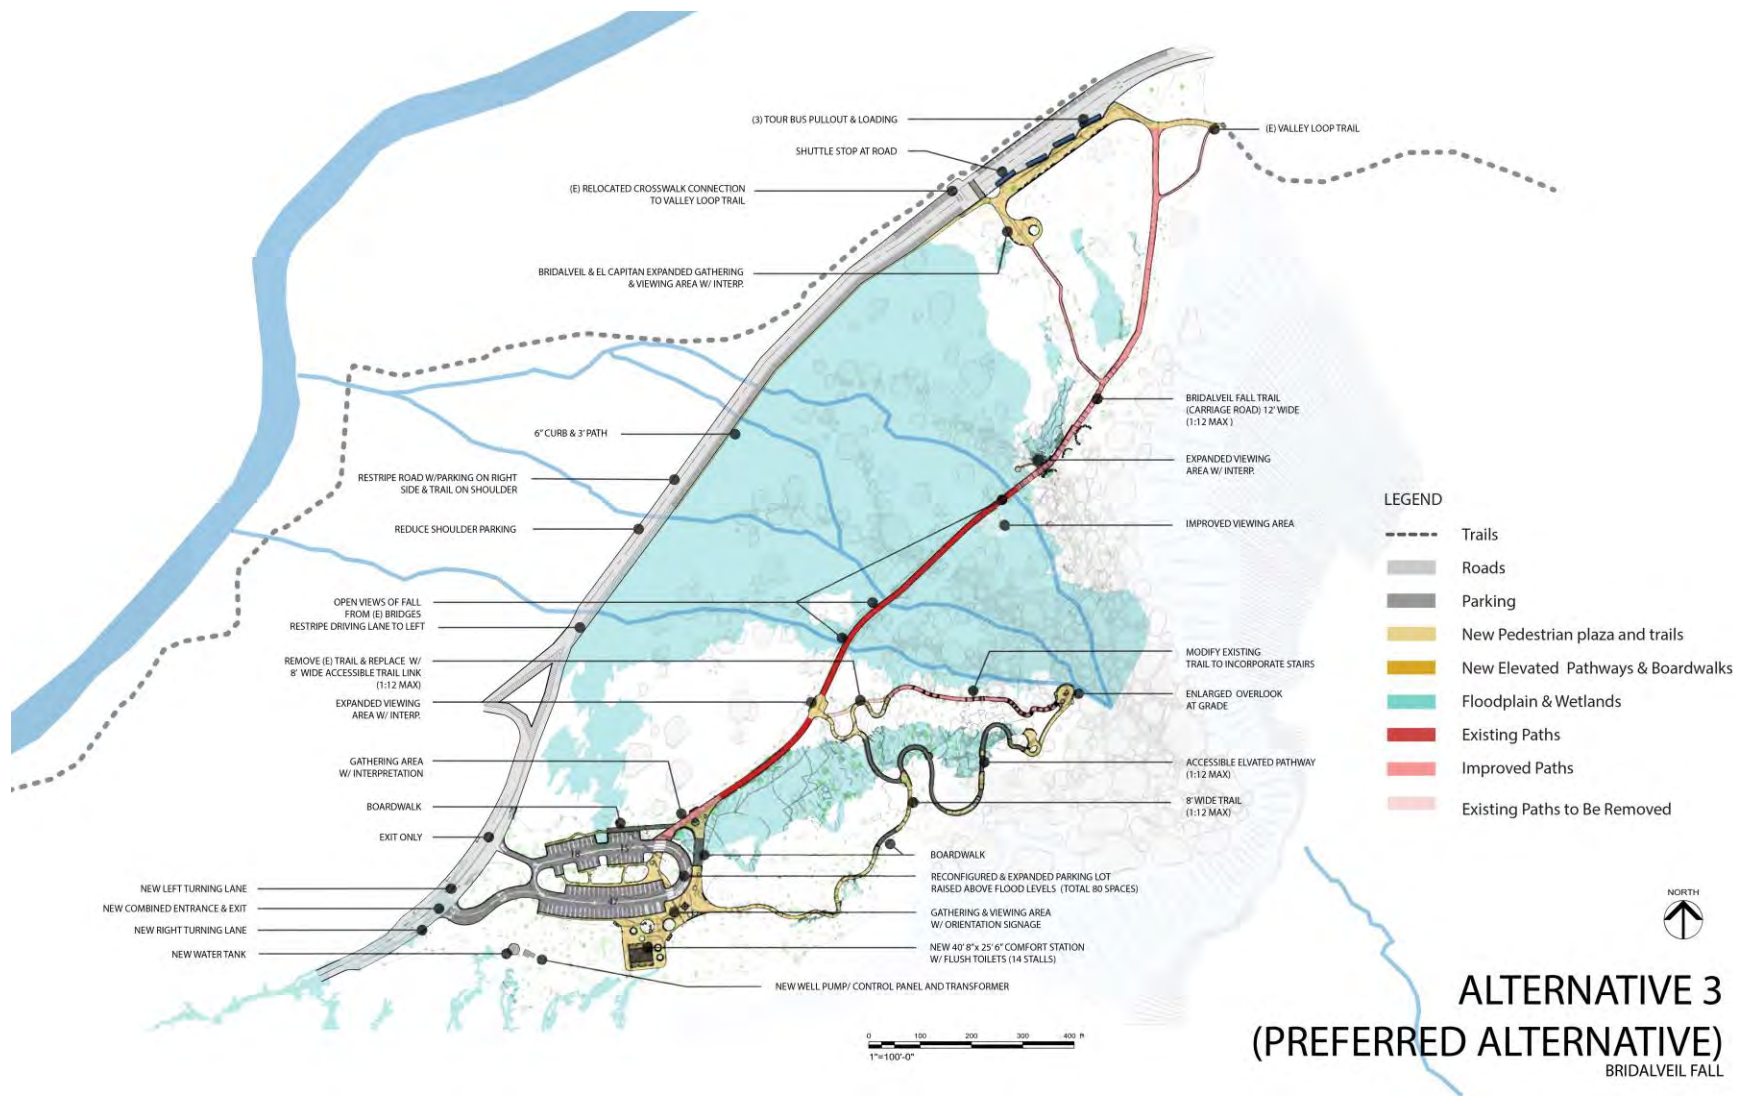
Figure 2. Preferred Alternative in Bridalveil Fall Rehabilitation Project EA

The *Bridalveil Fall Rehabilitation Project EA* considered one action alternative, Alternative 2, in addition to the preferred alternative considered in this Statement of Findings. Alternative 2 proposes additional facilities in the floodplain – a pedestrian bridge across Bridalveil Creek from the viewing platform near the base of the fall and an additional comfort station along Bridalveil Straight. The additional comfort station would be located in a non-high hazard area, outside deep flood flows and high velocities. The bridge across Bridalveil Fall would require additional Statement of Findings analysis to determine impacts on capital investment. The No Action alternative, Alternative 1, evaluated existing conditions in the area with no additional structures in the floodplain. The No Action alternative would not meet the purpose and need of the project.
