Yosemite National Park

1997 Flood Recovery Final Report

June 2013

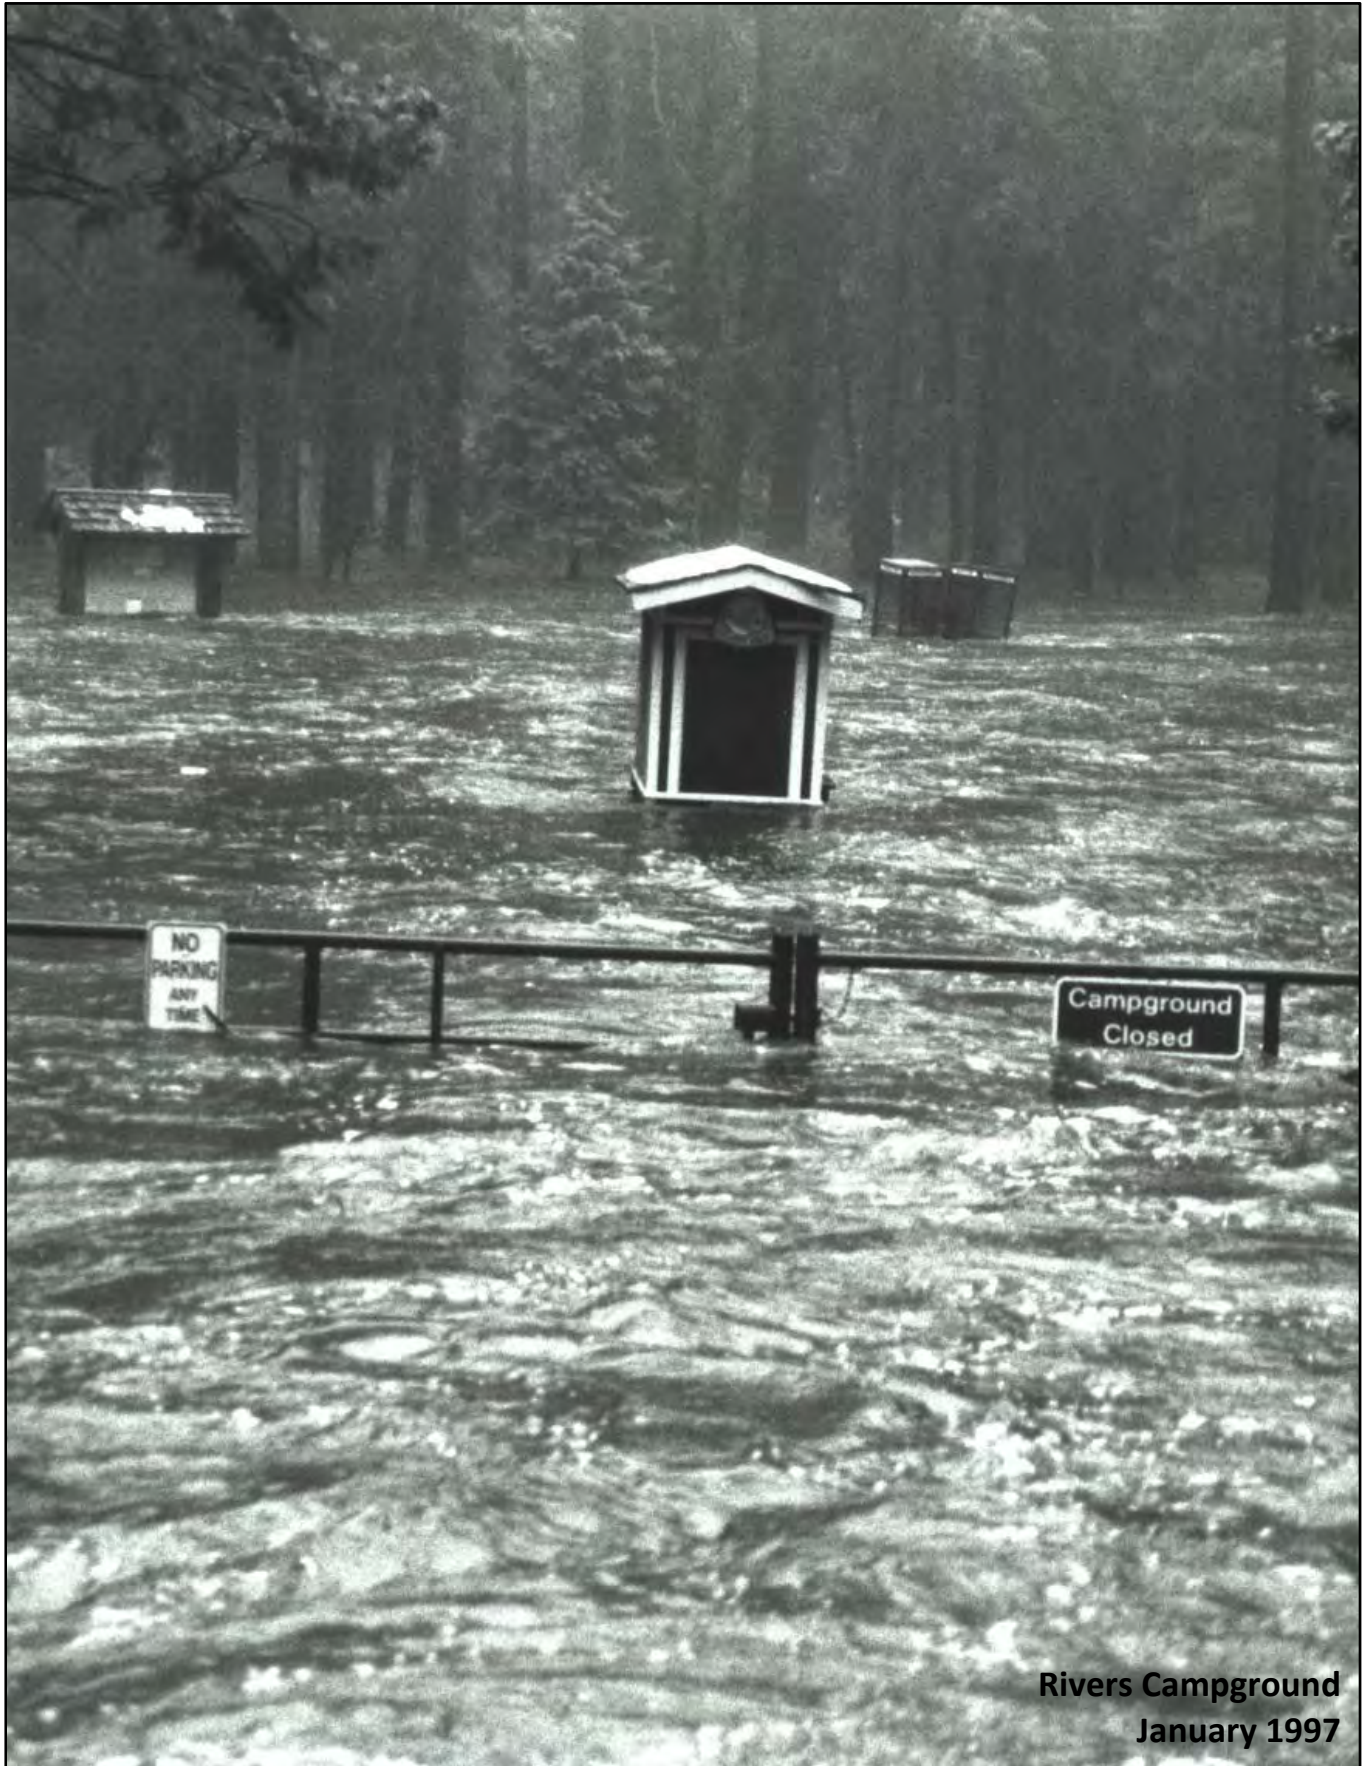
Rivers Campground
January 1997

- 3 Rivers Campground** – 278 campsites and nine restrooms were completely flooded. Campground furnishings were washed downstream. A layer of debris, silt and sand was left behind. The recreational vehicle dump station was damaged. The sewer lift station was flooded, damaging electrical equipment. The amphitheater walkway and site lighting were damaged.

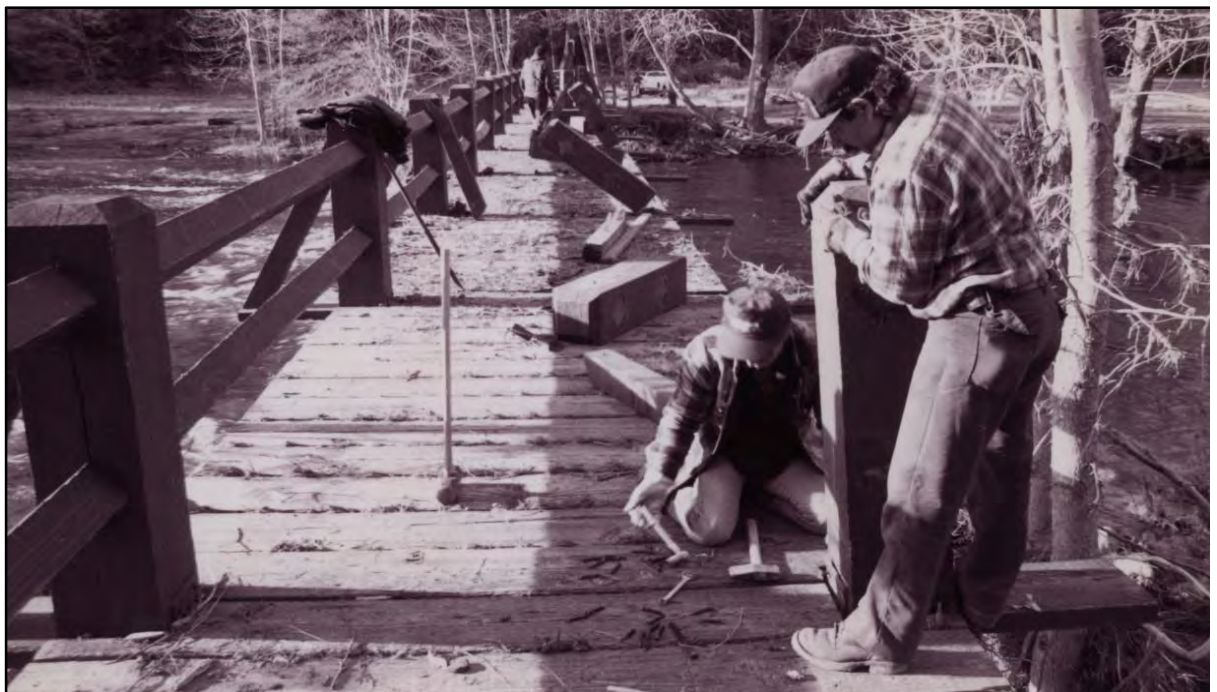
Superintendent's Bridge Under Reconstruction

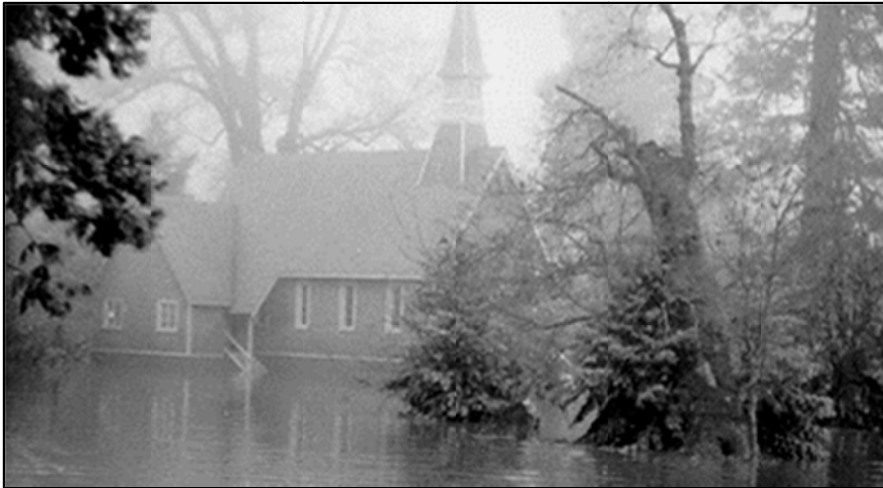
**Yosemite Chapel
January 1997**

- 9 Chapel Area** – The Yosemite Chapel flooded ruining furnishings, carpet, insulation, the heating system and rock skirting. The foot bridges and roadway were damaged in this area. Resource protection fencing was washed away.

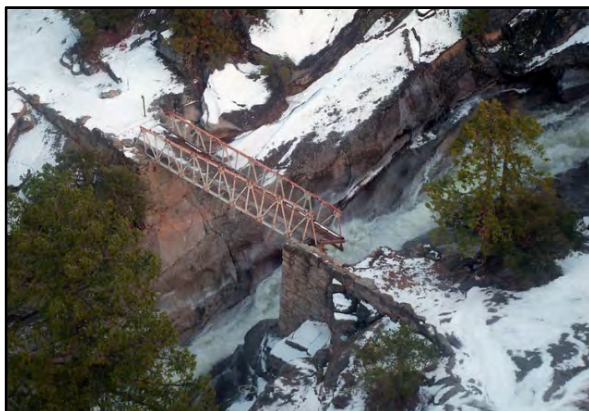
Silver Apron Bridge Before Repair

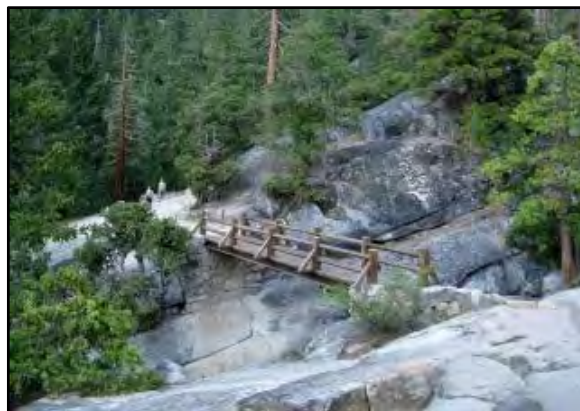
Silver Apron Bridge After Repair

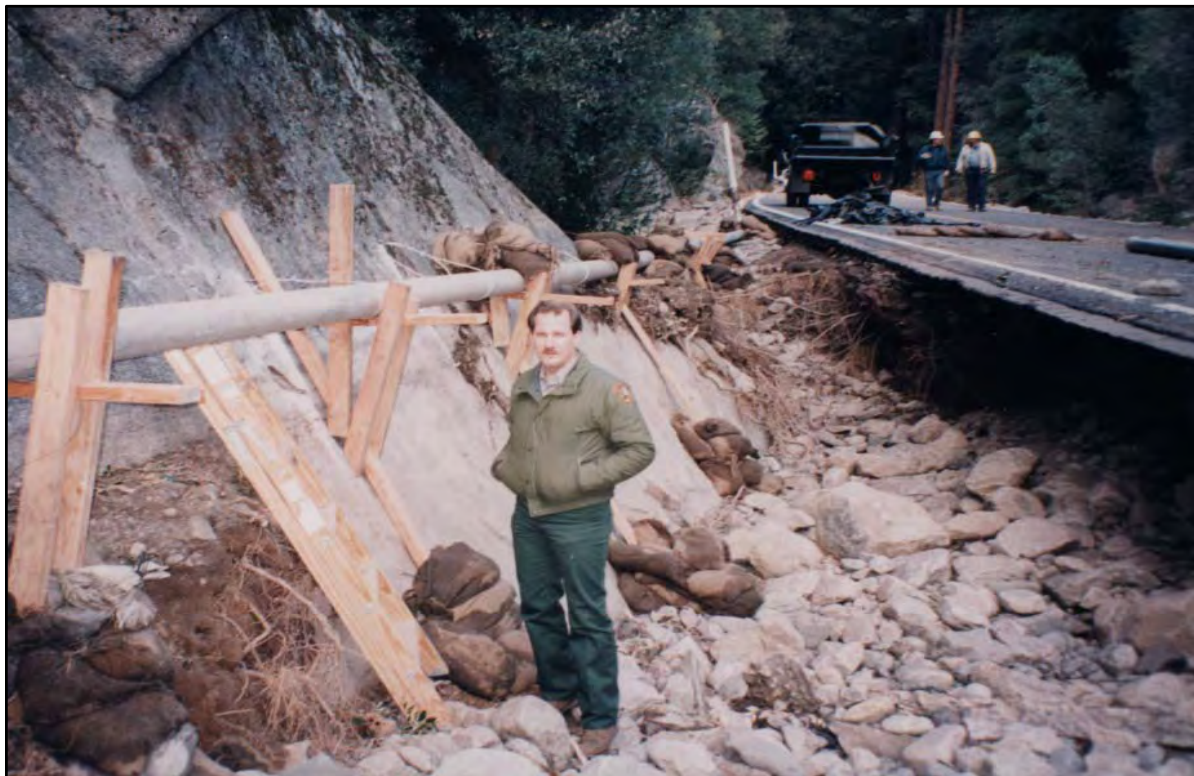
Temporary Sewer Line at Cascades

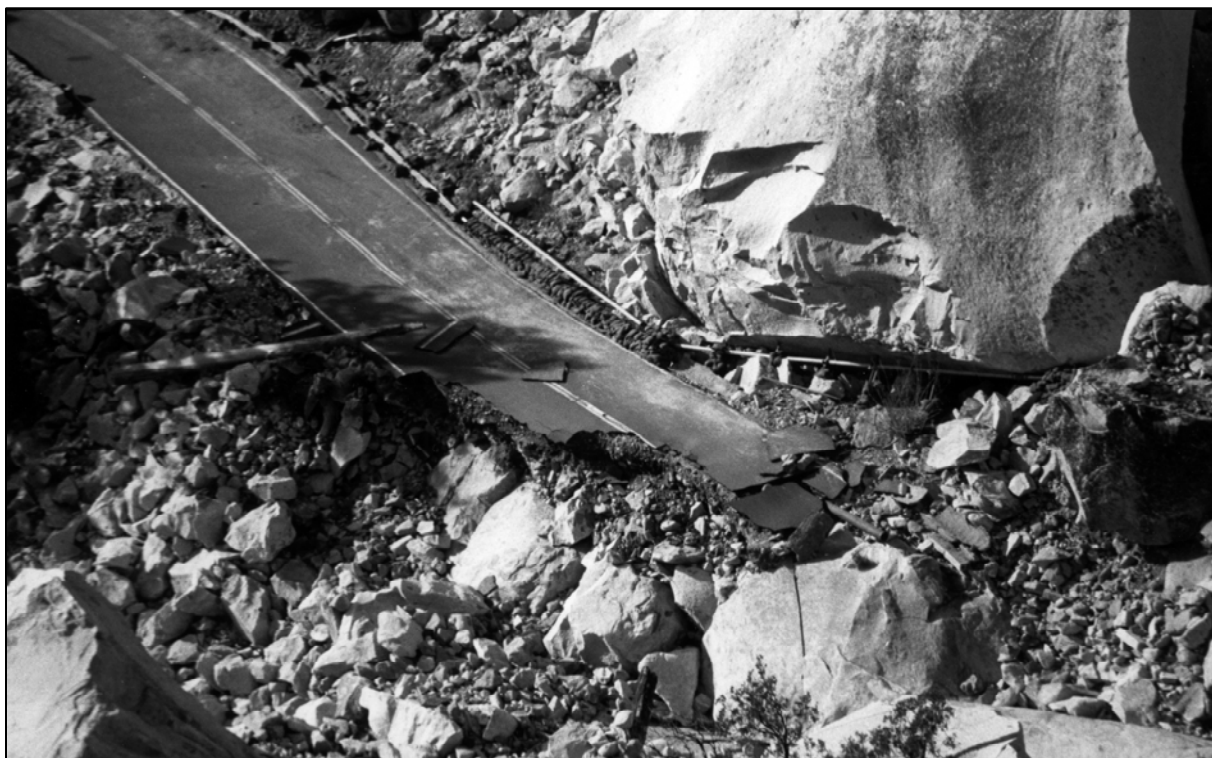
Aerial View of Highway 140 at the Cookie

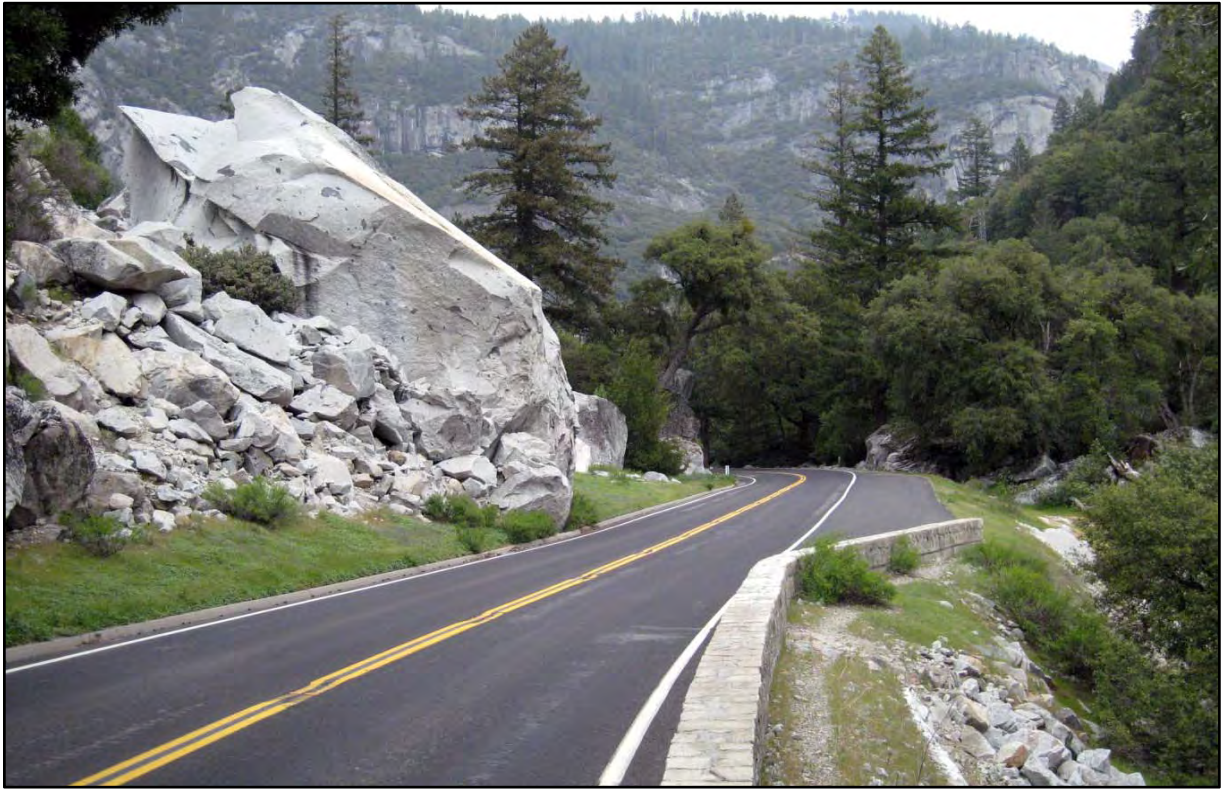
Post-Reconstruction of Highway 140 at the Cookie

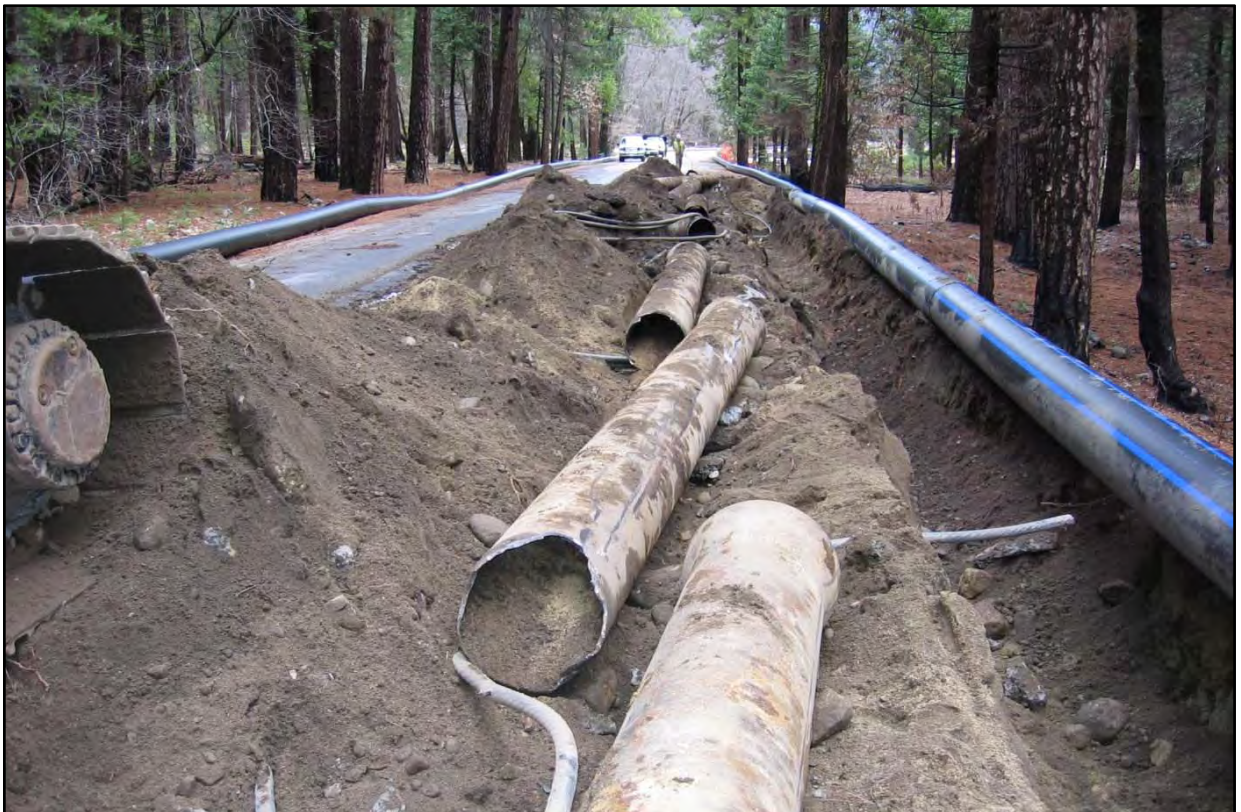
Post-Flood Sewer Line Replacement

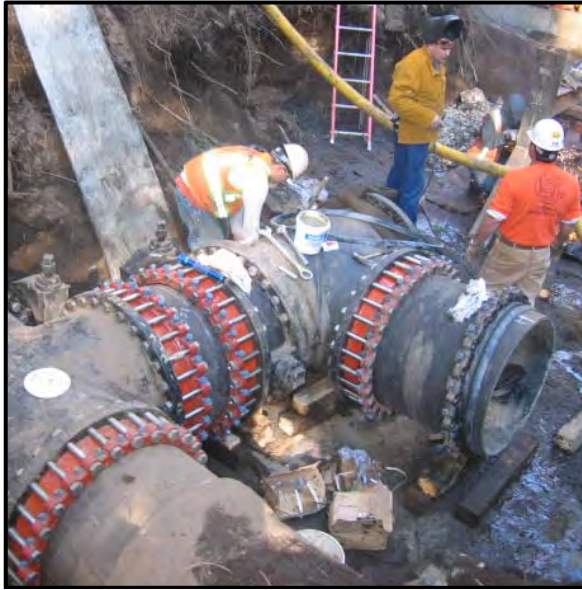
Installation of New Water Main

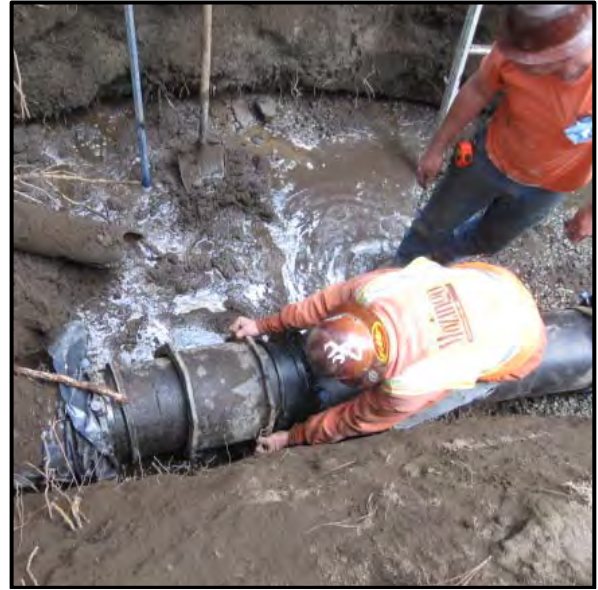
Installation of New Sewer Main

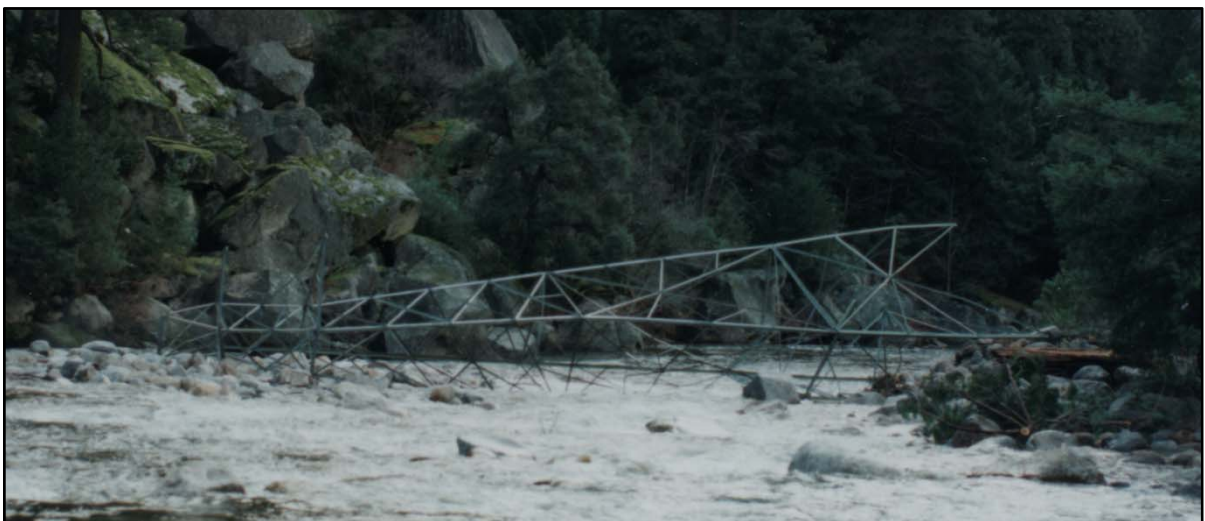
The primary power source into Yosemite Valley was compromised when flood waters partially undermined a power transmission tower. Other secondary power conduits were damaged or destroyed due to erosion and slope failures. Switching gear and transformers located underground were flooded and packed with silt.

Downed Electrical Tower in Merced River

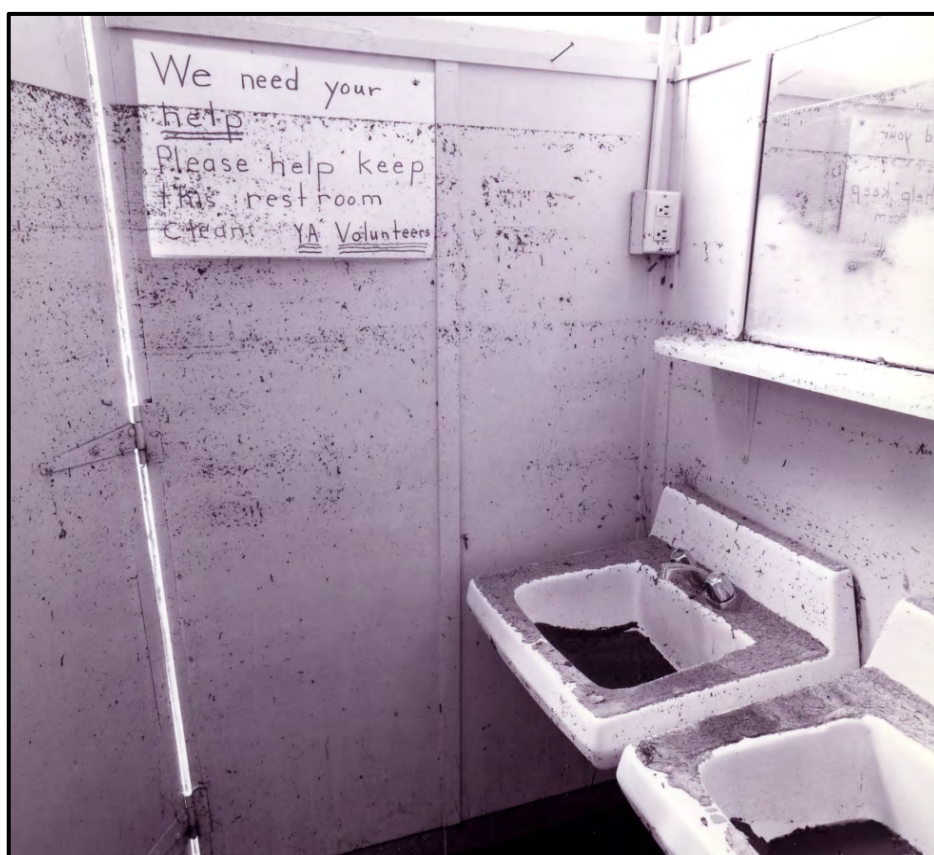
High water significantly damaged Sentinel and Yellow Pines picnic areas. Picnic tables and grills were washed away and required replacement. Flooding and silt deposit damaged parking areas and vault toilets throughout Yosemite Valley. These need to be cleaned and repaired prior to use. Flood waters also destroyed or damaged 32 educational, resource management and safety related exhibits. These exhibits promote resource preservation and visitor information, and will be repaired or replaced.

Silt Deposits in
Campground
Restrooms

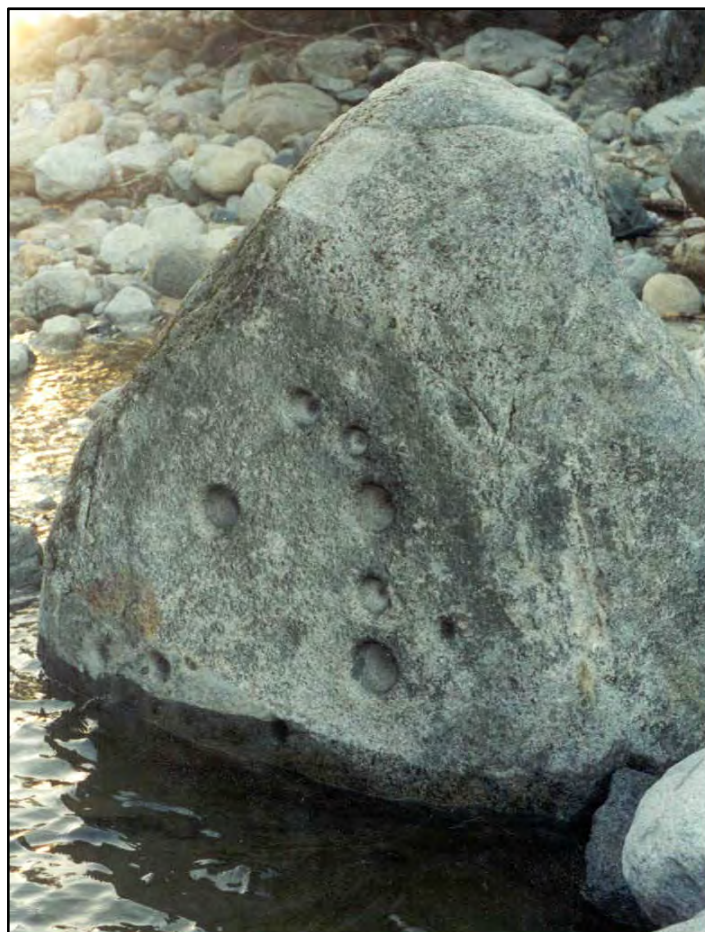
Granite Grinding Rock Displaced by Flood Waters

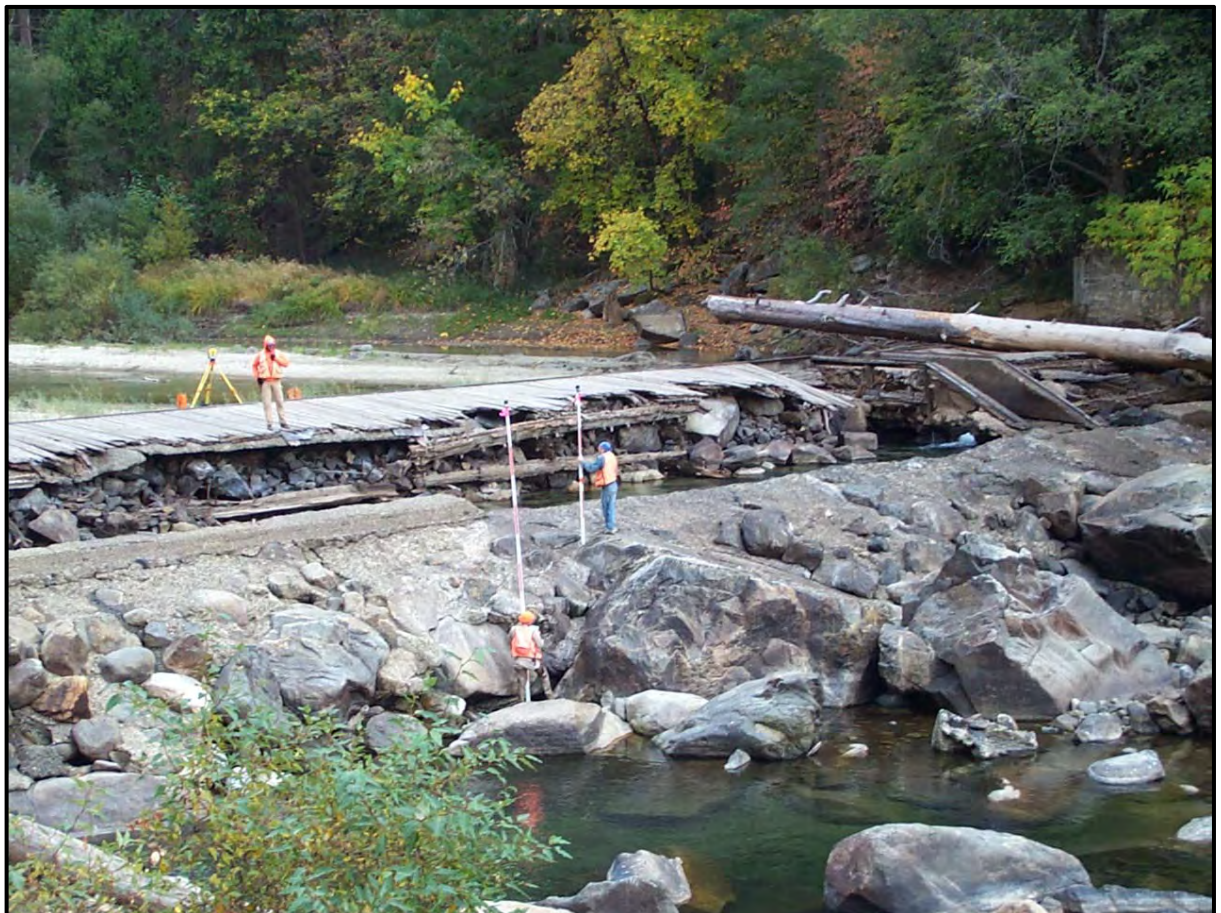
Cascades Dam Prior to Removal

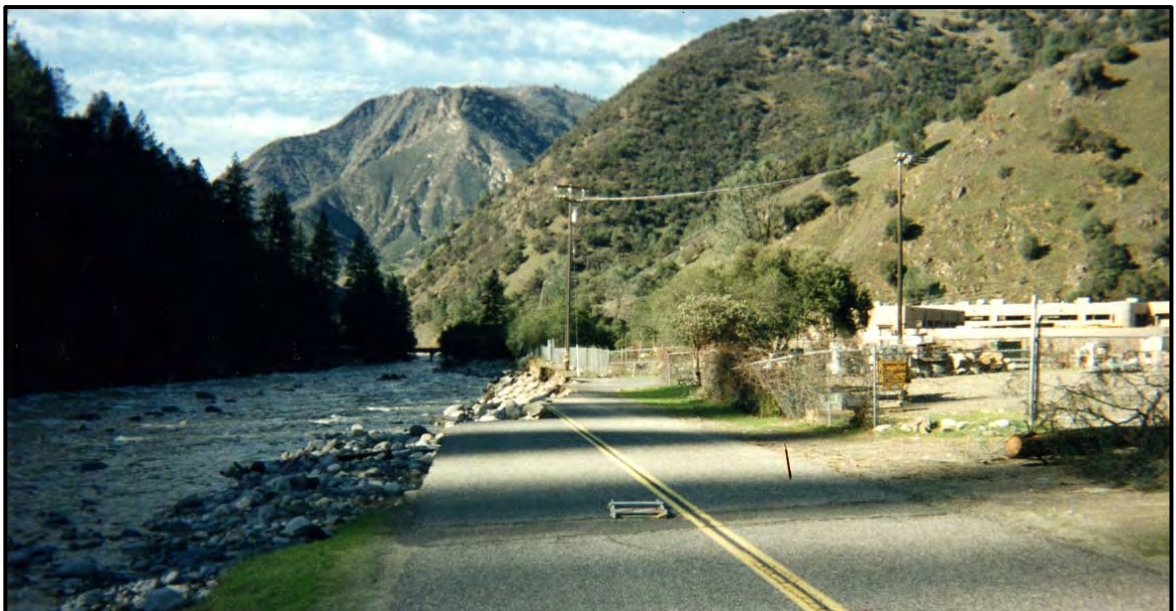
Flood Damaged El Portal Road in Front of El Portal Administrative Complex

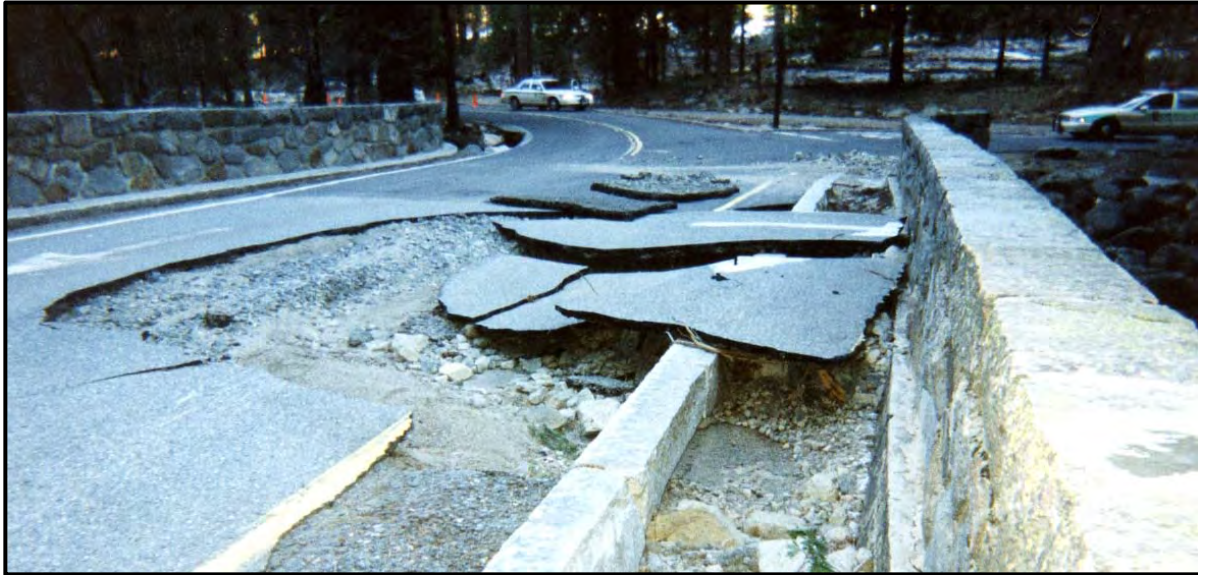
Road and Bridge Damage in Yosemite Valley

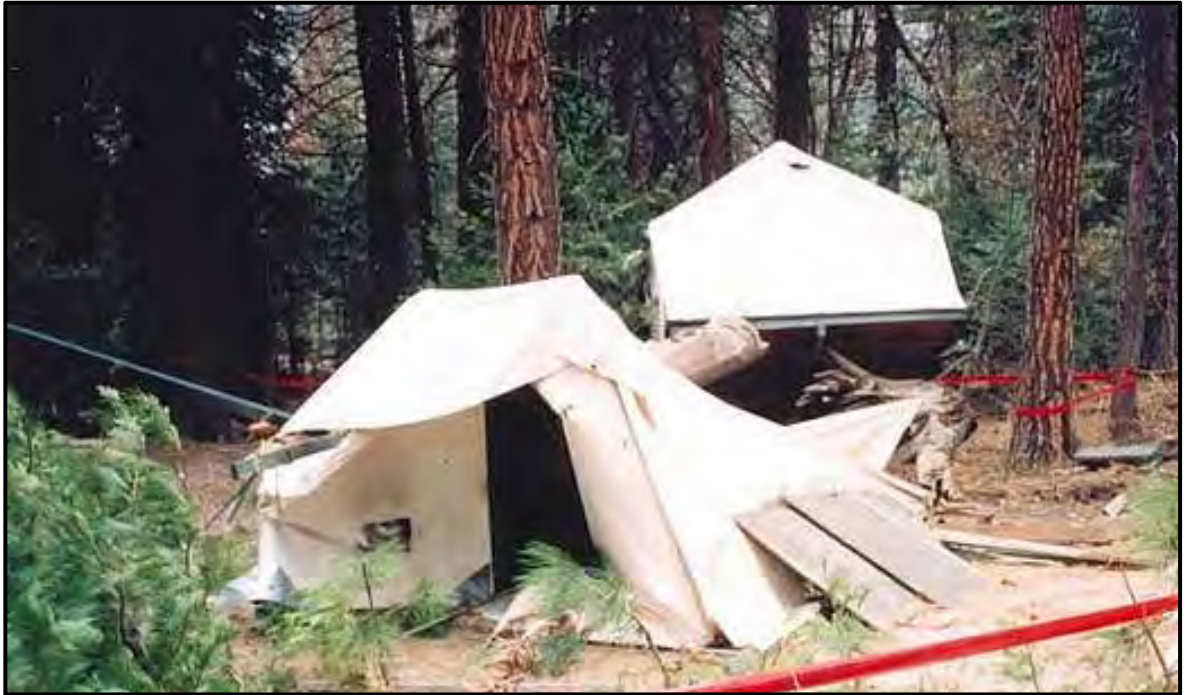
Destroyed Tent Cabins

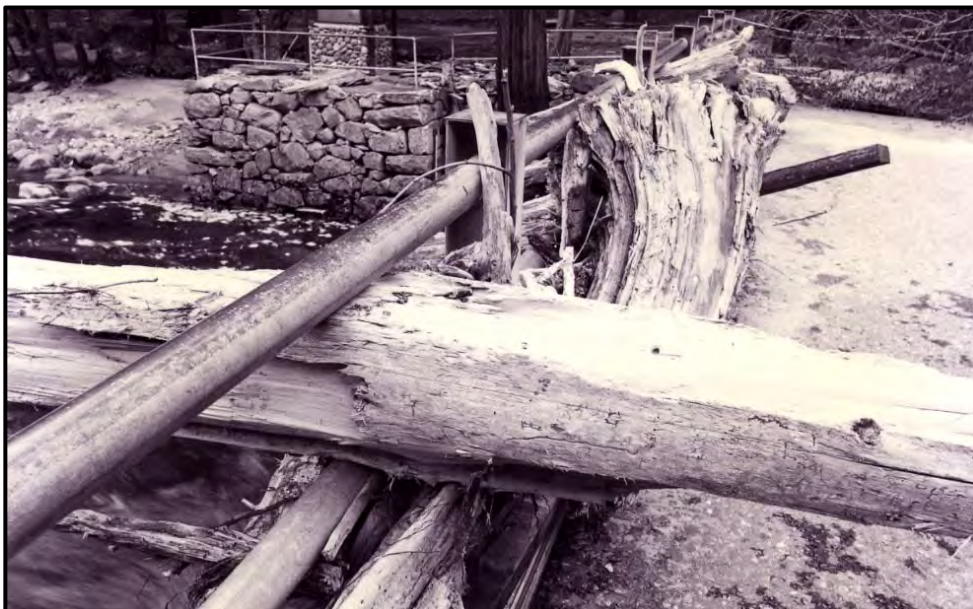
**Bridge Damage
in Yosemite**
