White Wolf Lodge Rehabilitation

Environmental Assessment / Assessment of Effect
February 2012

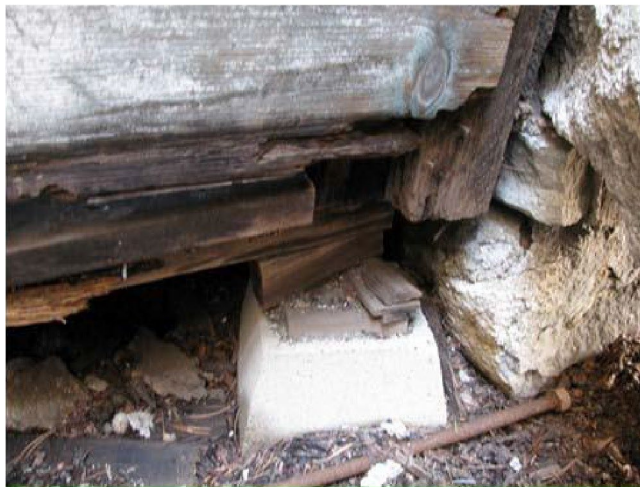
The primary building performance concerns relate to the foundations and floor framing (figures 6, 7, and 8). Severe decay of wood structural members and the displacement of support piers and footings have compromised the structural stability of the buildings. The recommended solution for these conditions is full replacement of the building foundations; and repair, replacement, and/or supplemental shoring of the floor in the Main Lodge building. Additional proposed upgrades include replacement of the power distribution system and electrical panels; and site grading and drainage/foundation improvements to minimize flow of water under the buildings

Figure 6. Erosion and settling of foundations

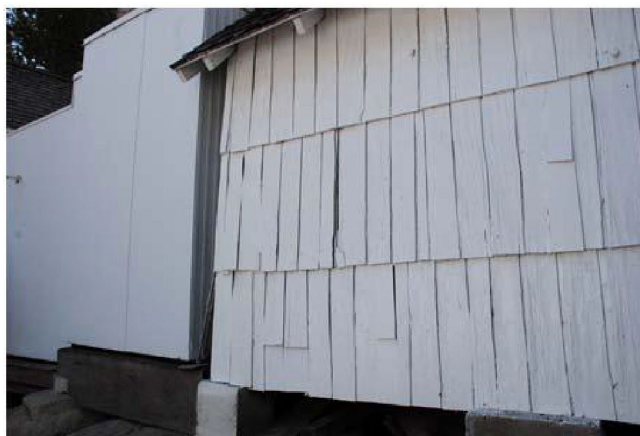
Figure 7. Deteriorating wood-shingle siding

- Replace wood-shingle siding at the storage building in-kind. Paint siding white to match surrounding structures.
- Replace board-and-batten siding on Duplex Cabins where decay and buckling occurs.

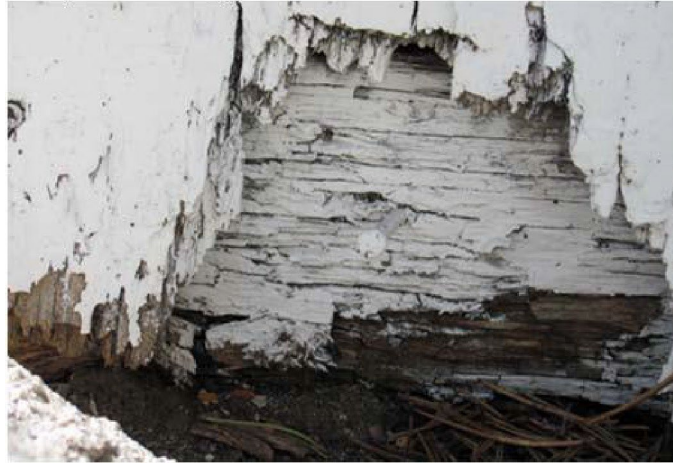
Figure 8. Decayed exterior wall
