Snake River Land Company

Grand Teton National Park

Historic Structure Report

Prepared by
Colorado State University
Architectural Preservation Institute
Christopher Koziol, Principal Investigator

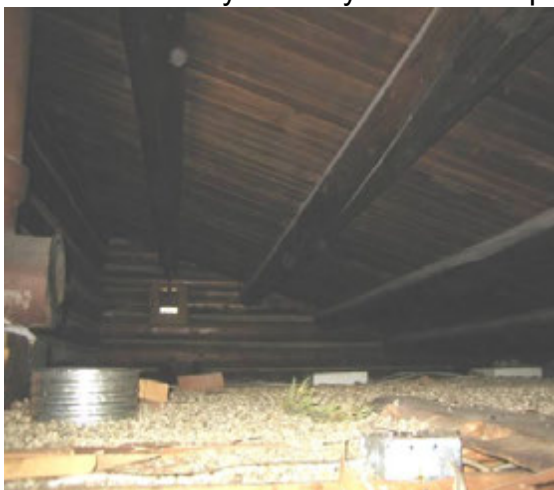
Figure 42

- One is the roof system consisting of the log purlins with 2x4 rafters spanning from wall to ridge and bearing on the purlins. Snow loads can be huge especially in the Teton area and the 3:12 roof pitch does not shed snow effectively.
- Another area of concern is the loft living space. Depending on the use, the floor system may not be adequate to support a living area and or storage area. There are log joists supporting this area and they are spaced at forty-eight inch centers.

There are several ways to correct this such as a steel flint plate down the middle of the log floor joist. Again a structural engineer will need to inspect and design the corrections to be made in these two areas.

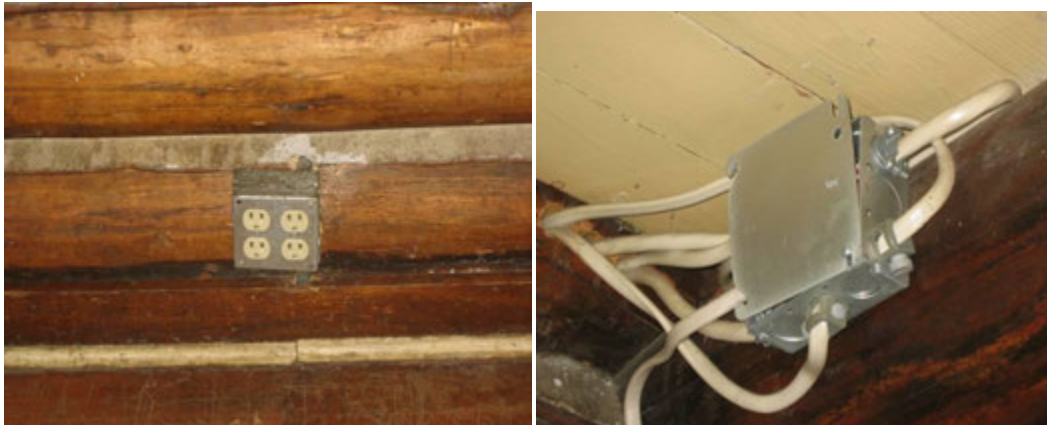
Figure 57

The electrical system has been updated with copper wiring, new panel, and most outlets seem to be grounded as well. The concerns here are code issues. A good portion of the wiring inside is stapled to the logs and exposed. There is also evidence in the basement and crawl space of rodents chewing on wires with bare wires exposed.

J-box with exposed wires in living space

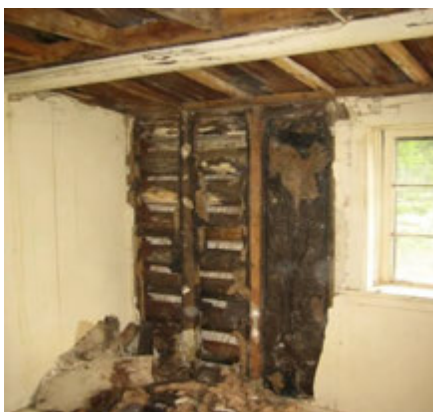
Figure 58

Roughly 90% of the structure has exposed logs for the interior walls. The same is true for the ceiling, exposed log rafters, floor joists, or purlins with wood sub decking on the roof structure. However there are five areas where this is not the case. Four areas, bedrooms 2 and 3, kitchen, and utility area have had furring strips nailed to the logs with drywall over the furring. In all of these areas the drywall was then painted except for one wall in the utility area where wall samples were taken. The first layer of covering here was fabric wallpaper. Over the fabric wallpaper was a wallpaper to resemble a faux wood paneling. The correct way to restore these areas is to

Bedroom #3-wall furring with Gypsum board

- Pull off all the drywall and check for rot behind and replace. Alternatively, it may be acceptable to remove sheetrock and furring strips and leave logs exposed.

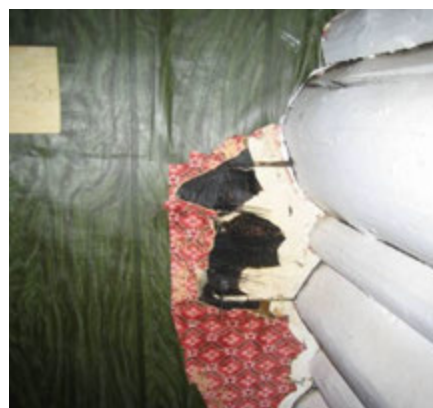
Utility room wall coverings
